### Stream Visual Assessment Protocol

(Modified by the Rutgers Cooperative Extension Water Resources Program, [www.water.rutgers.edu](http://www.water.rutgers.edu))

Stream Name FIRST NESHANIC Grid ID D3

Reach Location CR523

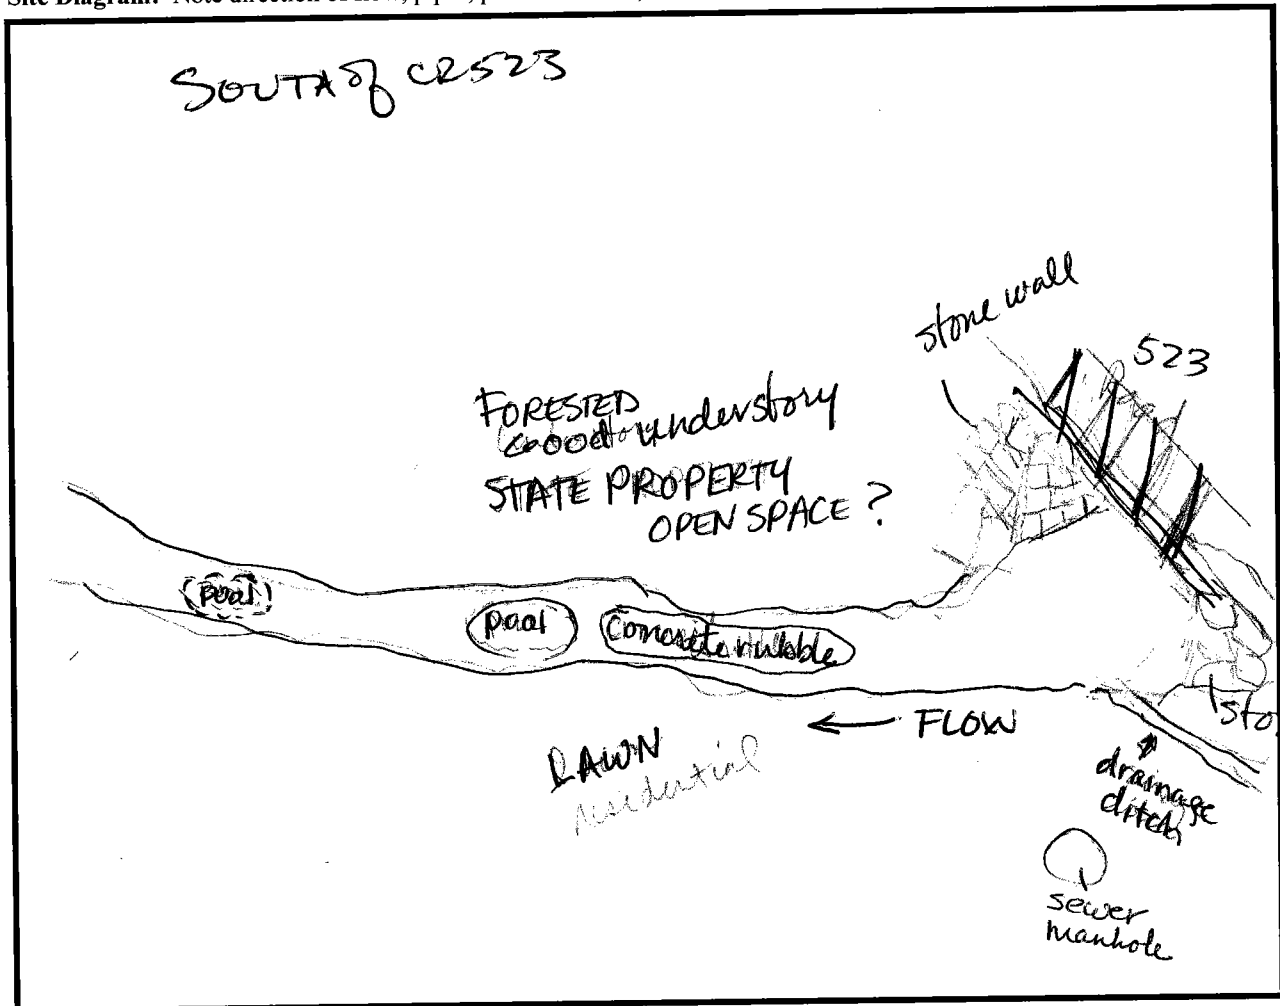
Site Diagram: Note direction of flow, pipes, photo locations, stream characteristics, stormwater infrastructure, & ditches.

MAY BE BACKWARDS

Riparian Zone Left: 2 Right: 10

Bank Stability Left: 6 Right: 9

YES - CONCRETE CHUNKS + PIECE OF PIPE IN STREAM -  
Neighbor reported that during floods, lots of rubble imbeds  
in this stretch - she + her husband remove it.  
Additional comments:

Adjacent neighbor reports during heavy rains ~~the~~ stream  
overflows her lawn up to 75 feet -

LEFT BANK COULD BE PLANTED WITH NATIVE  
VEGETATION - DRAINAGE DITCH NEEDS TO BE DUG OUT  
TO PREVENT FLOODING TO LAWN

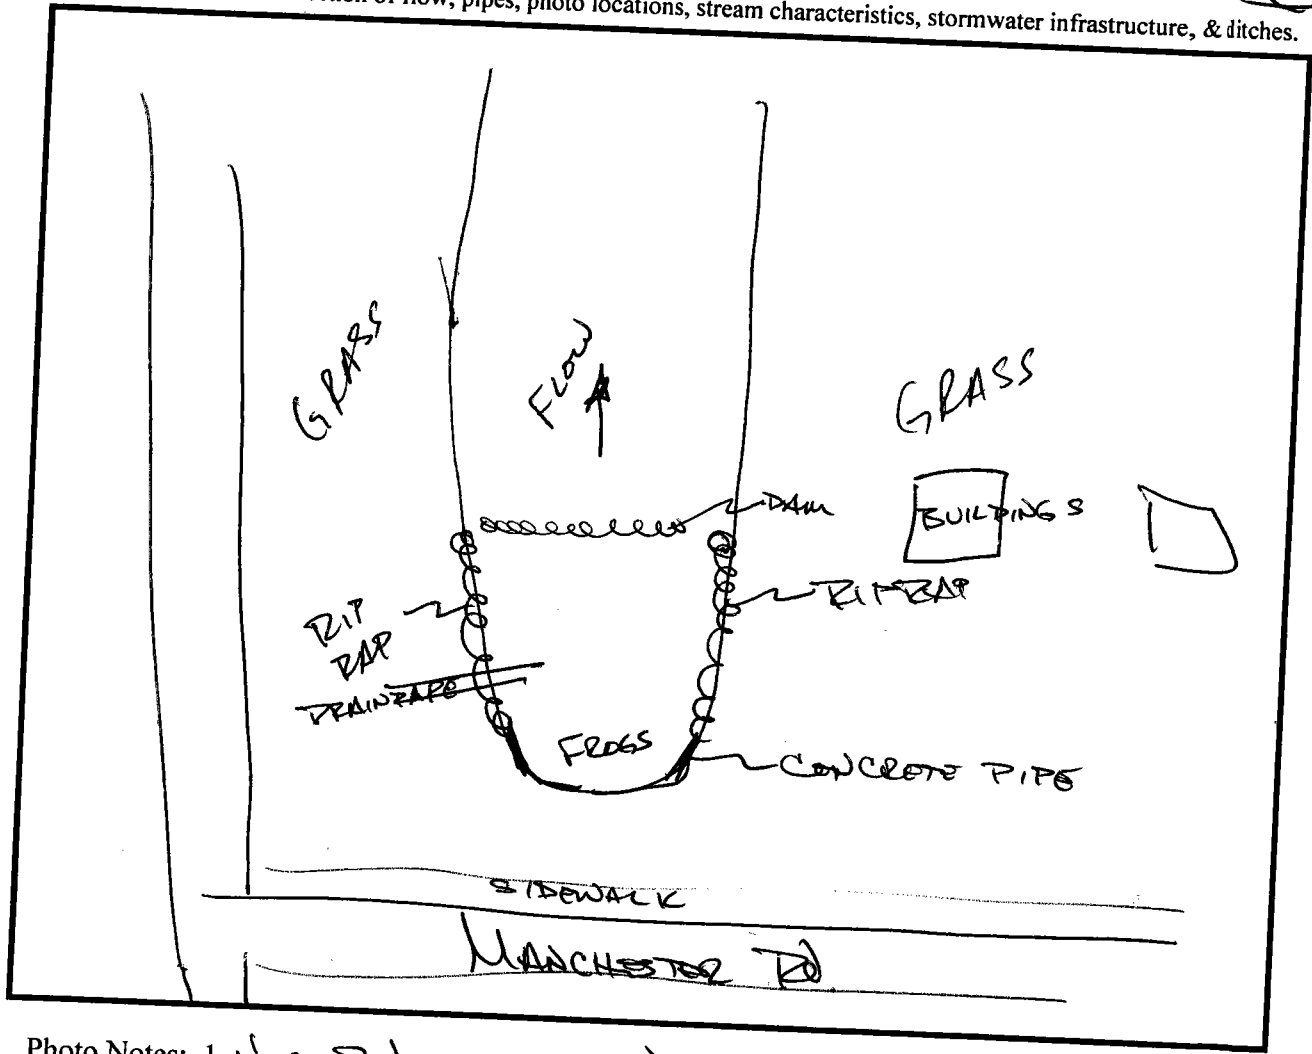
Site Diagram: Note direction of flow, pipes, photo locations, stream characteristics, stormwater infrastructure, & ditches.

South of MANCHESTER RD. - RIP RAP  
#1 MANCHESTER RD. - RIP RAP  
- DAM (CIRCLES)

SW STRUCTURE  
- No real flow

NO RIFFLES

*Mosquito Breeding Ground*

*Create more natural situation*

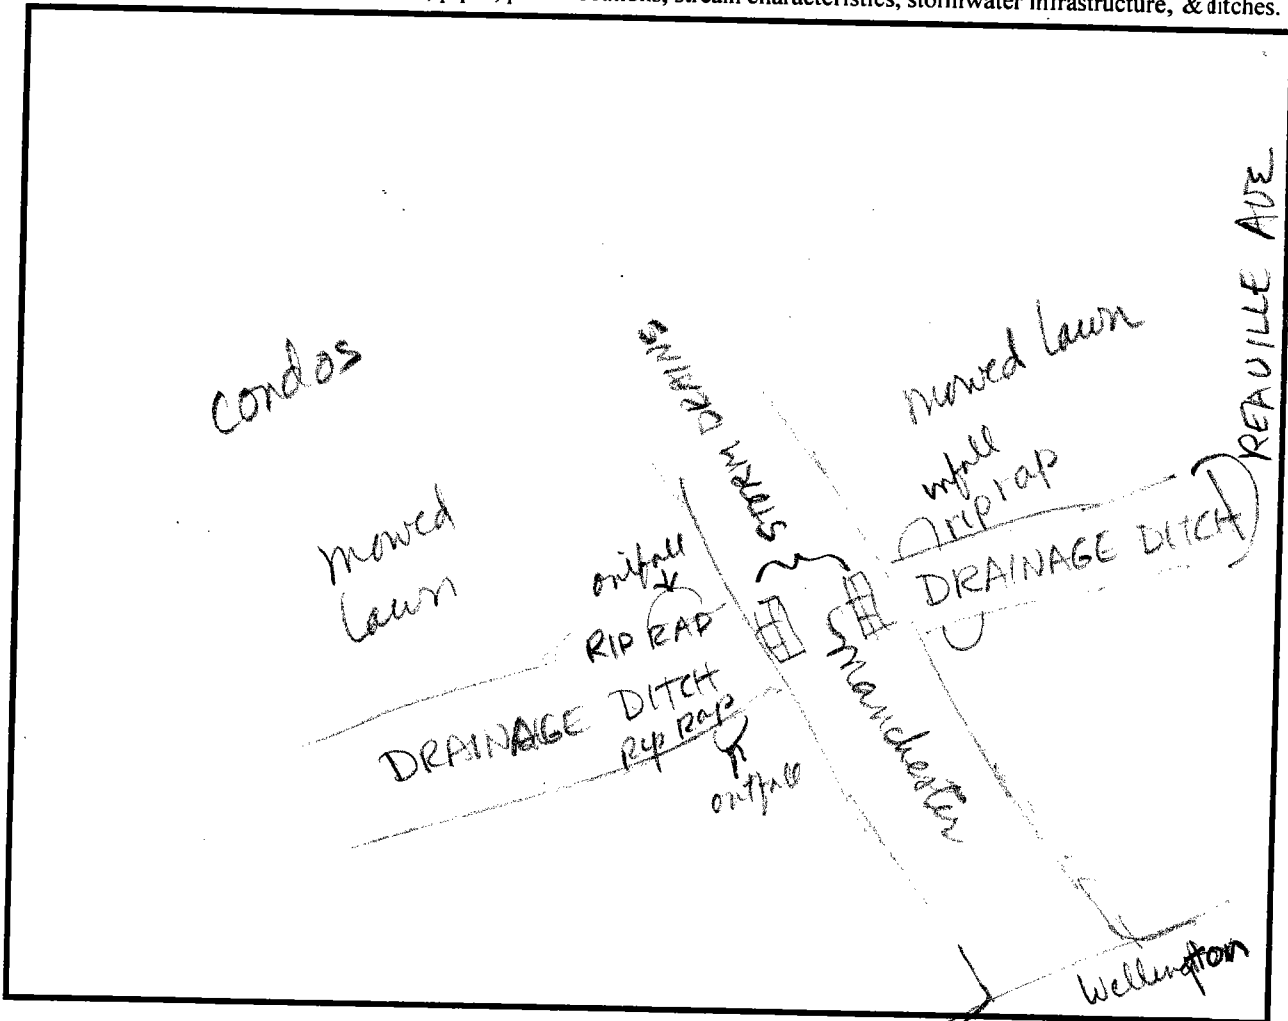
Site Diagram: Note direction of flow, pipes, photo locations, stream characteristics, stormwater infrastructure, & ditches.

Reach Location REACH IS ESSENTIALLY A STORMWATER STRUCTURE

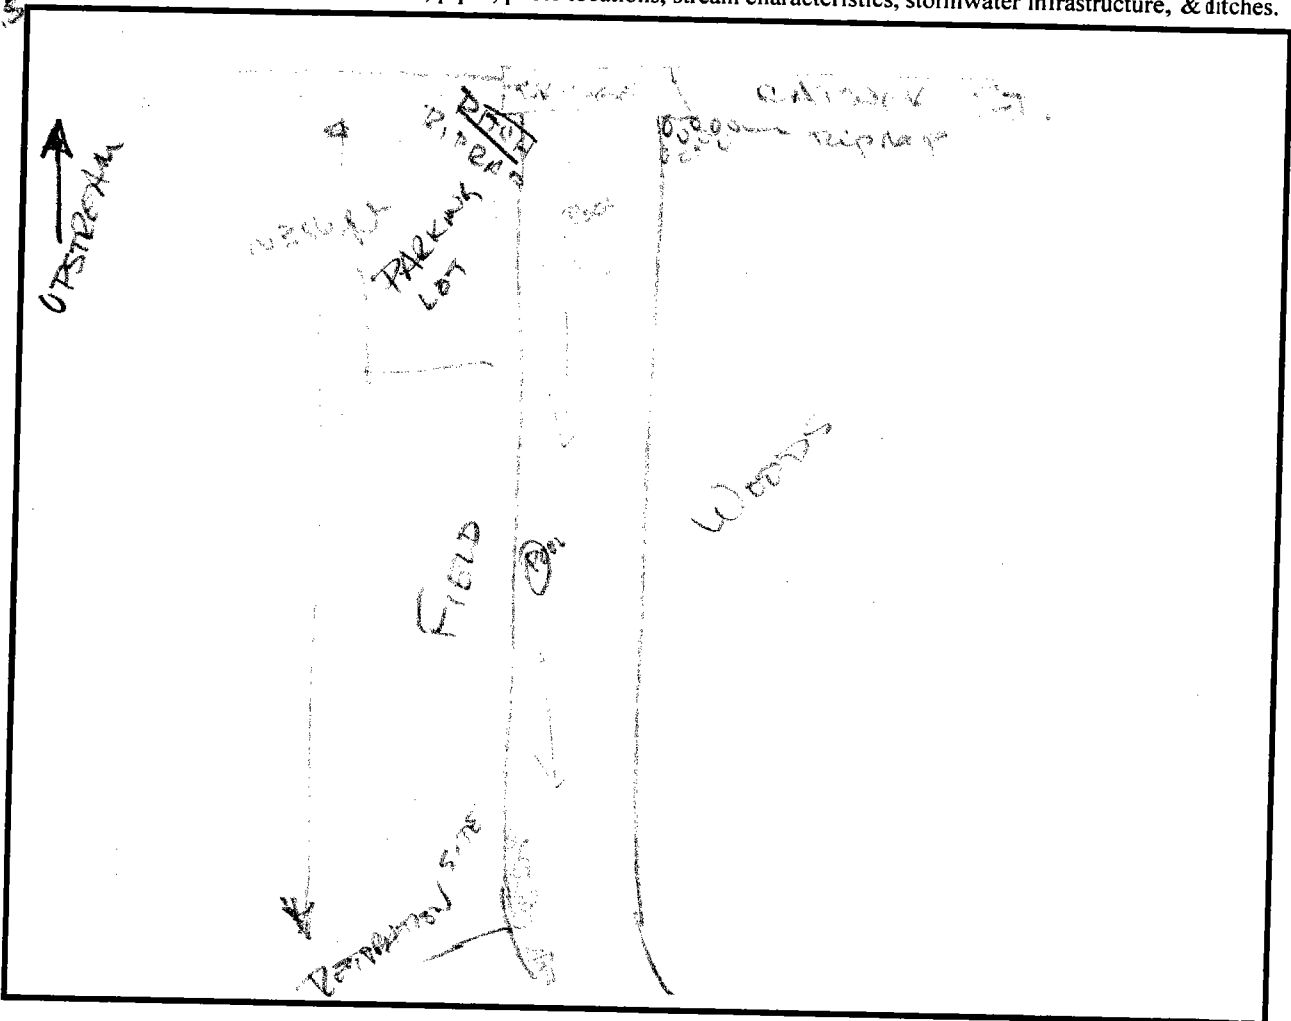
Site Diagram: Note direction of flow, pipes, photo locations, stream characteristics, stormwater infrastructure, & ditches.

Channel Condition *Very poor*  1 *Riprap concrete walls*

planting + larger riparian buffer on left side
