Stream Visual Assessment Protocol

(Modified by the Rutgers Cooperative Extension Water Resources Program, www.water.rutgers.edu)

Stream Name 2nd Wash Grid ID C4-15

Reach Location RT 202 - STORAGE PLACE

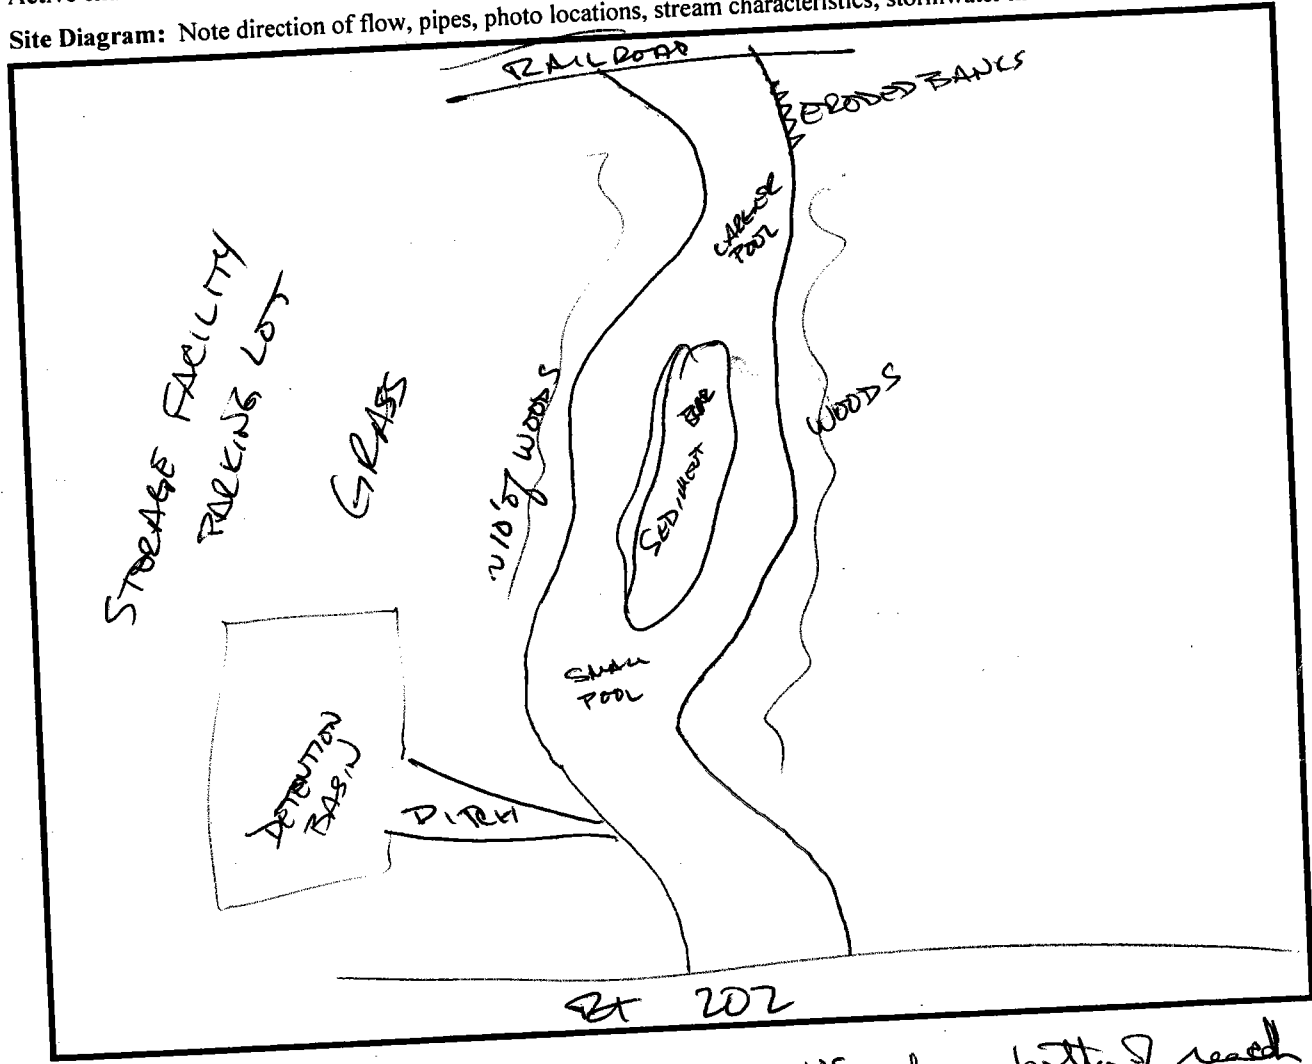
Site Diagram: Note direction of flow, pipes, photo locations, stream characteristics, stormwater infrastructure, & ditches.

- Photo Notes:
1. RT 202 Bridge
 2. US from bottom of reach
 3. _____
 4. _____
 5. ERODED BANK
 6. RAILROAD BRIDGE
 7. DITCH FROM DETENTION BASIN
 8. _____
 9. _____
 10. _____

Need to determine why water is murky
Given dry weather, is there any running water in nearby stormwater structures?

Stormwater structures @ rd crossing

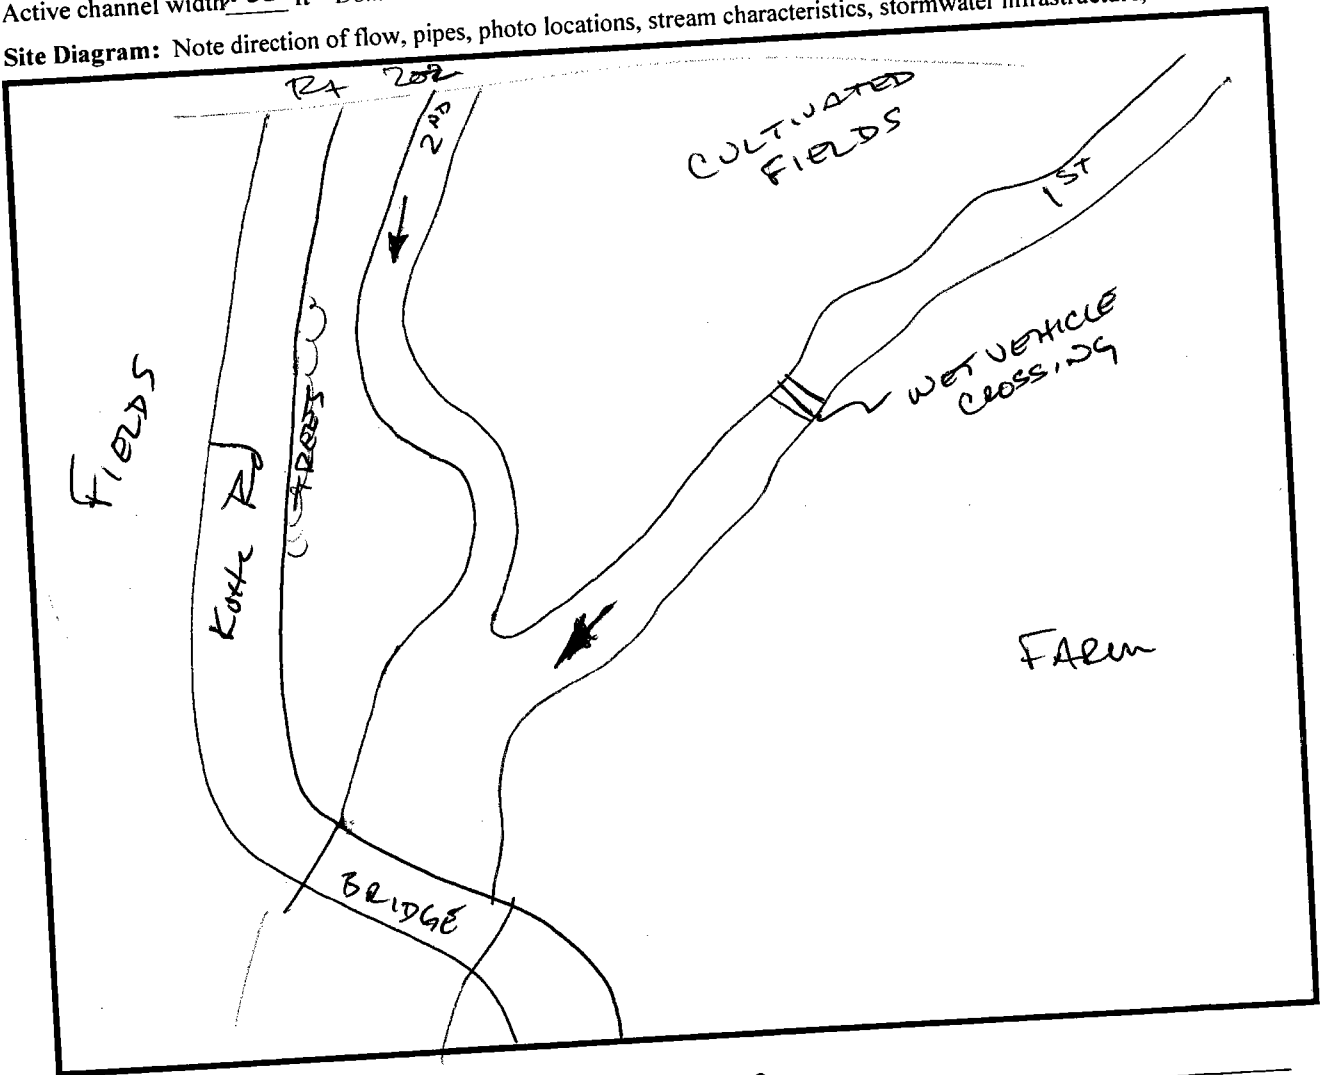
Site Diagram: Note direction of flow, pipes, photo locations, stream characteristics, stormwater infrastructure, & ditches.

YES - GOOD AMOUNT - TIRES

Close to Rt 202 outfall

Do you have suggestions for remediation along this reach?
INCREASE BUFFER, STABILIZE BANK

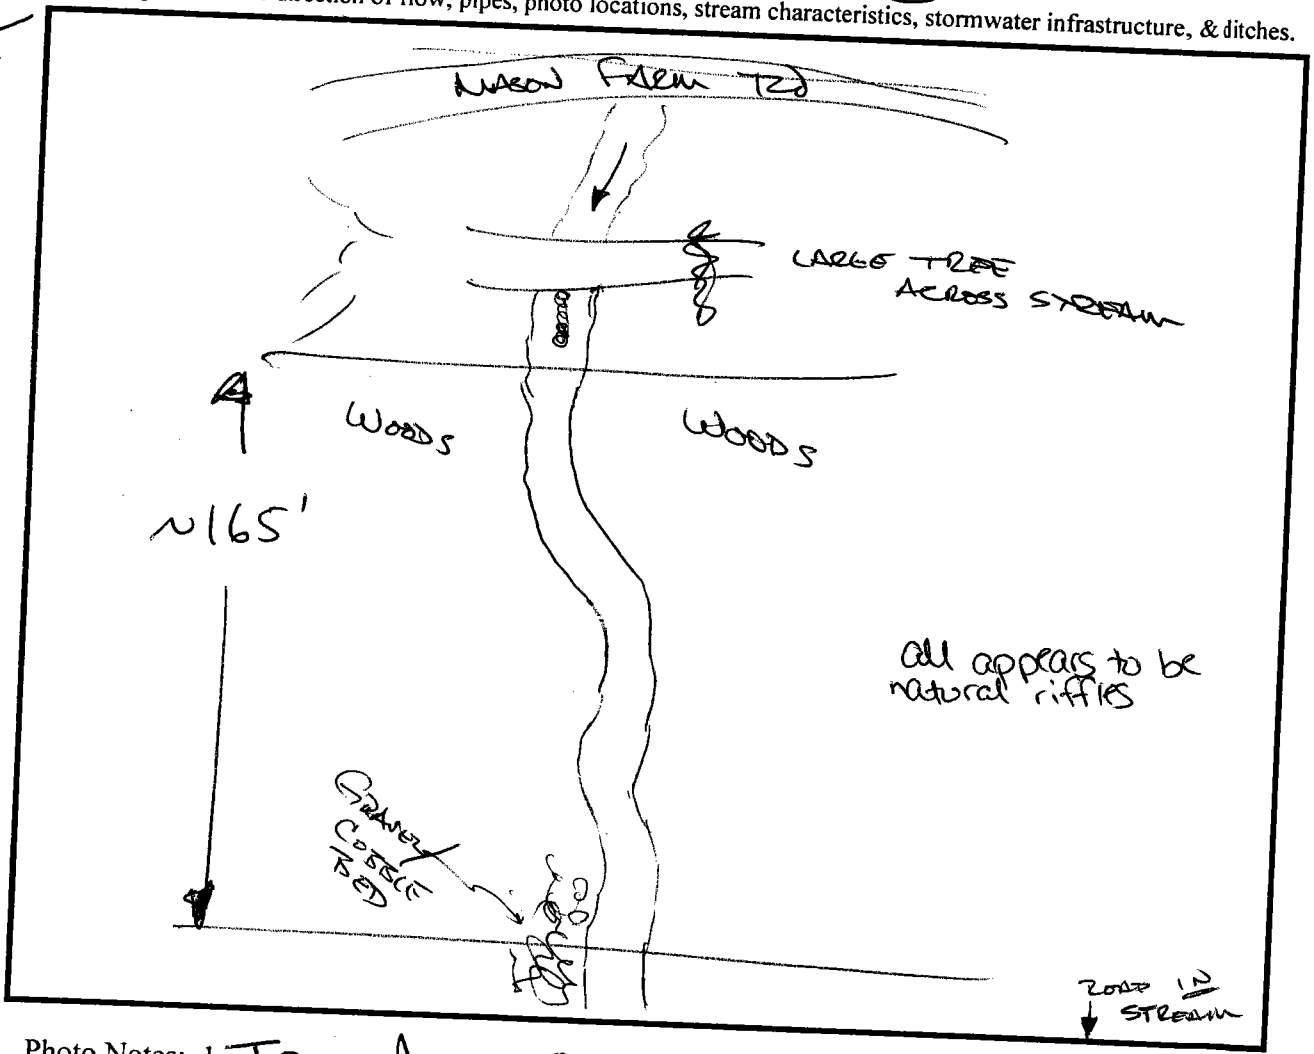
Site Diagram: Note direction of flow, pipes, photo locations, stream characteristics, stormwater infrastructure, & ditches.

| 1. <u>Tree across stream</u> | 2. <u>Looking DS from start of SUAP</u> |
| 3. <u>Looking Upstream from Endpoint</u> | 4. <u>road crossing stream</u> |
| 5. <u>road crossing stream</u> | 6. _____ |

Pools no pools in this stretch, nice pools down stream
 Invertebrate habitat

yes - road run off/storm water

difficult access due to Multiflora

Kill Multiflora

Create crossing downstream

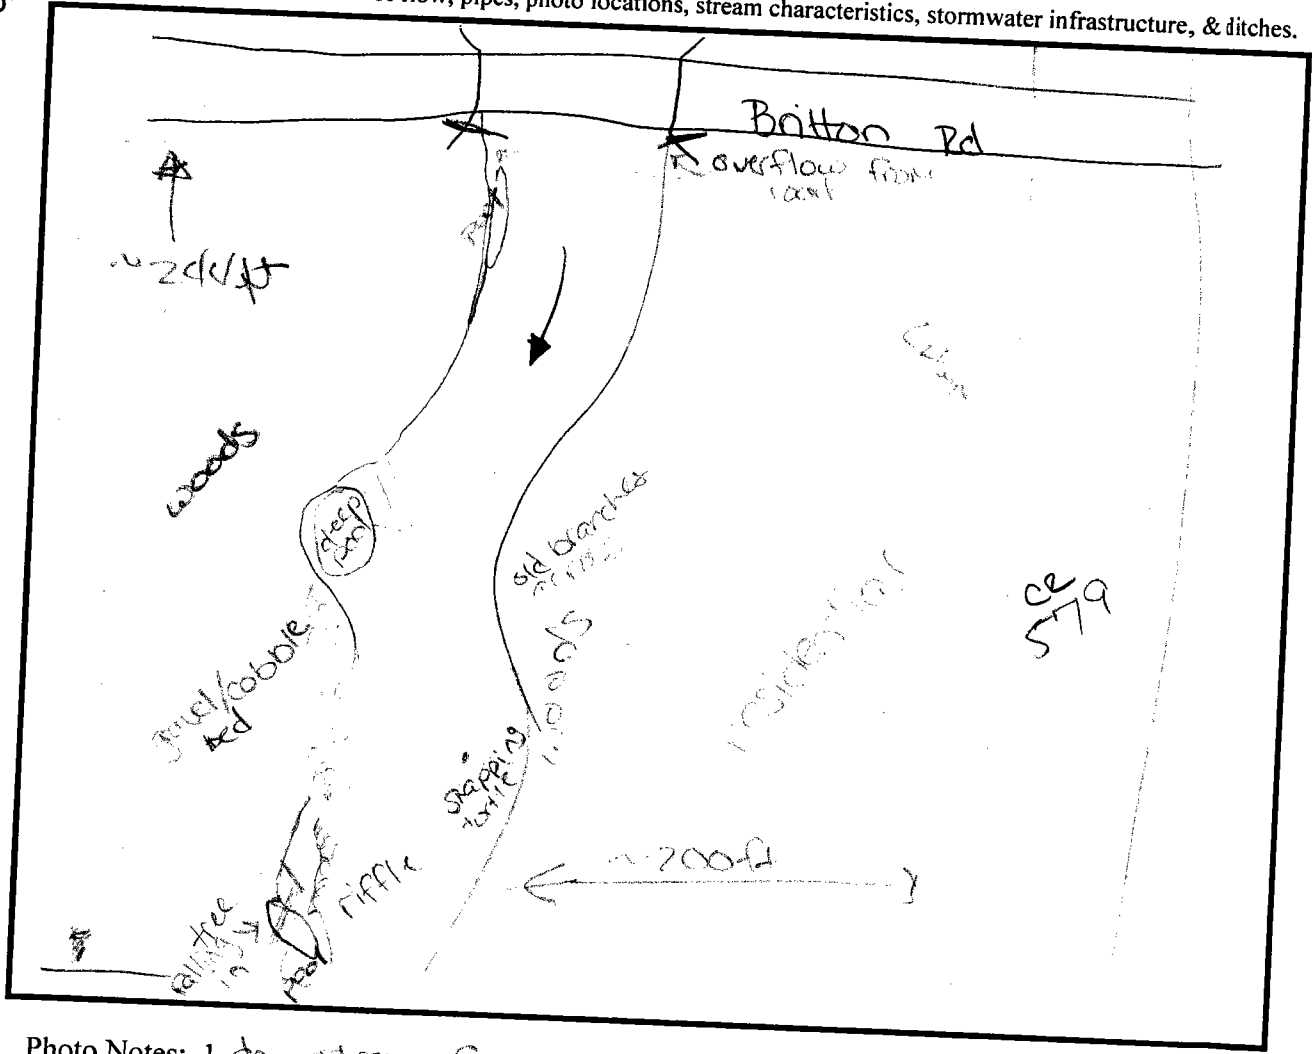
Site Diagram: Note direction of flow, pipes, photo locations, stream characteristics, stormwater infrastructure, & ditches.

- Photo Notes: 1. downstream from ridge 2. looking downstream at midstream
- 3. _____
 - 4. _____
 - 5. _____
 - 6. _____
 - 7. _____
 - 8. _____
 - 9. _____
 - 10. _____

no pipes in reach, but drainage from all sides of both sides of bridge

yes, storm water runoff + ypc trash

invasive removal
reconnection to flood plain

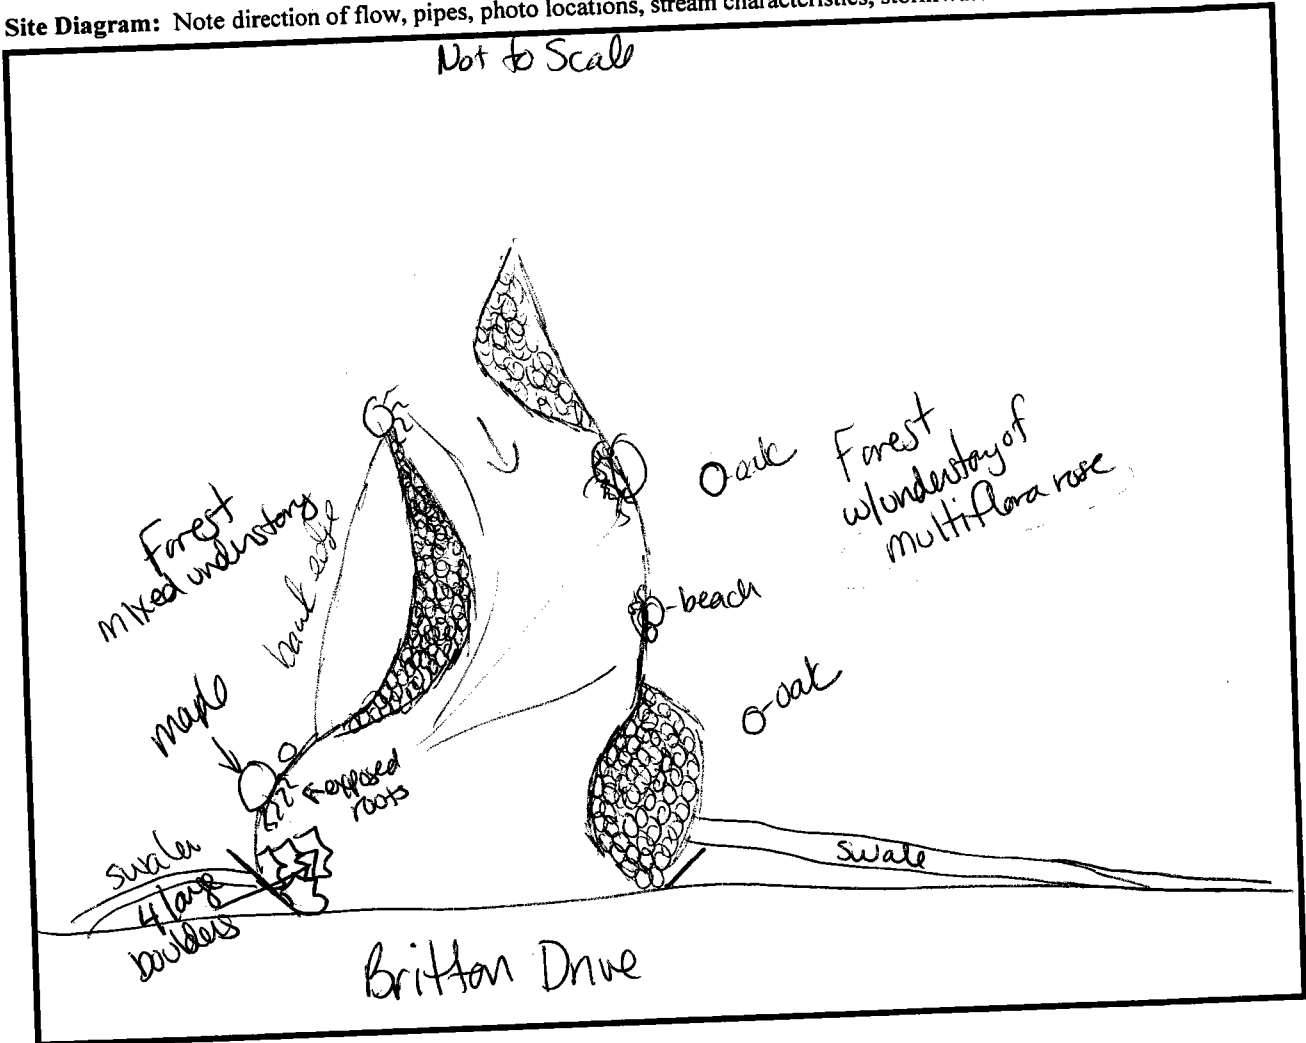
Site Diagram: Note direction of flow, pipes, photo locations, stream characteristics, stormwater infrastructure, & ditches.

Gary has knowledge of flooding and downcutting problems upstream
off here on Bizer Rd. Point bars and erosion may be related
to conditions up there.

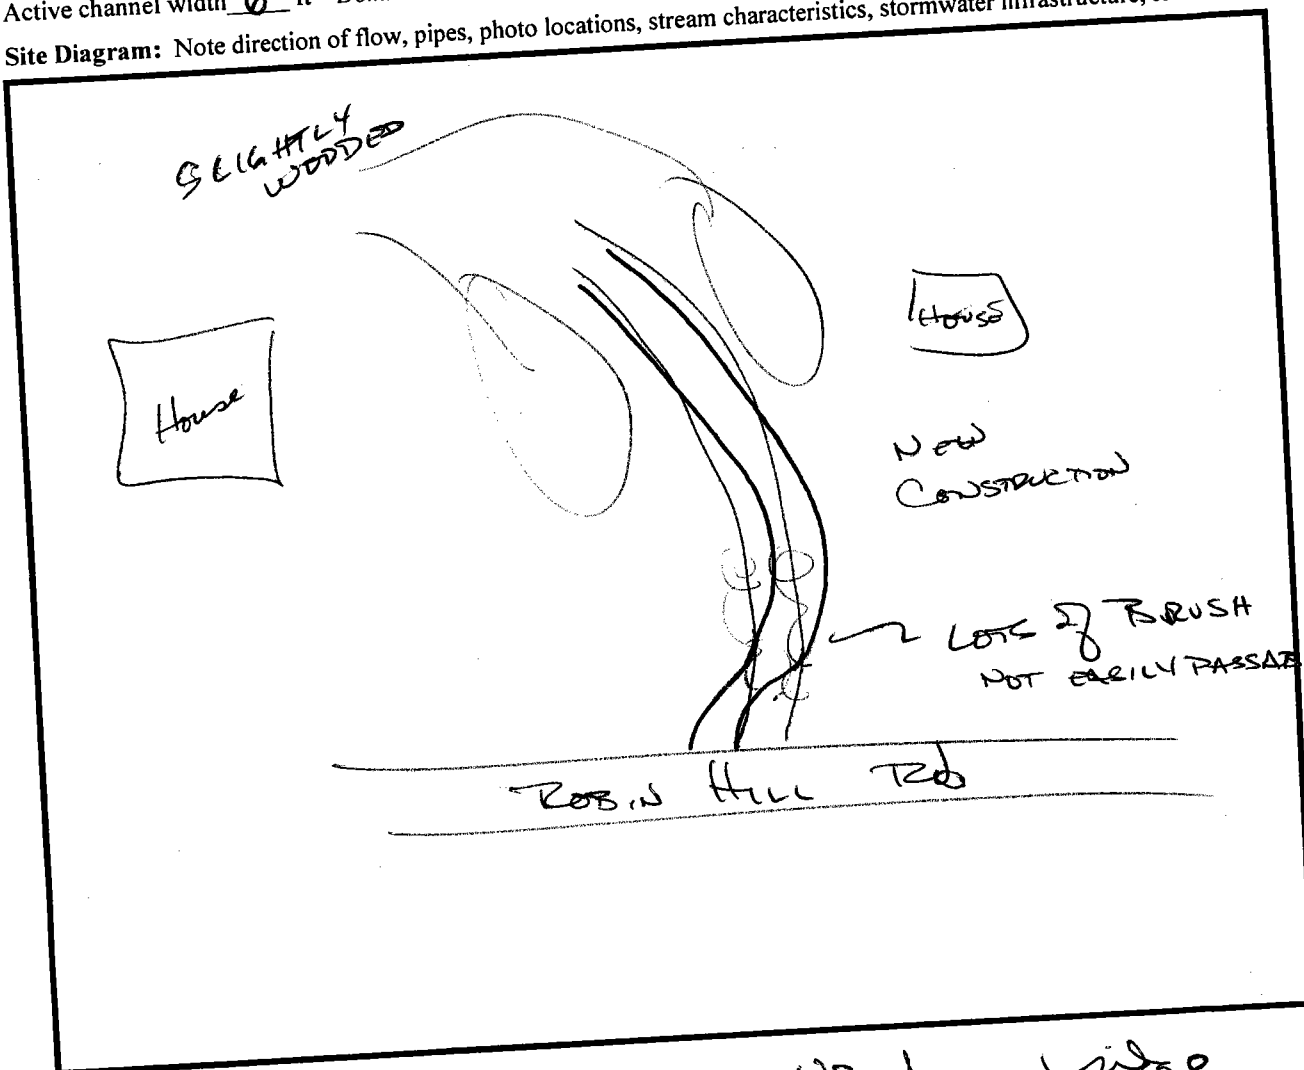
Site Diagram: Note direction of flow, pipes, photo locations, stream characteristics, stormwater infrastructure, & ditches.

- Photo Notes:
1. Top of Bridge
 2. US from bridge
 3. Stream exposed in right bank
 4. _____
 5. _____
 6. _____
 7. _____
 8. _____
 9. _____
 10. _____

w/ CONSERVATION
EASEMENT AROUND STREAM
of least 25' on EACH
SIDE - Now owners +
New CONSERVATION HAVE
NOT STARTED MAJOR
LANDSCAPING
