Stream Visual Assessment Protocol

(Modified by the Rutgers Cooperative Extension Water Resources Program, www.water.rutgers.edu)

Stream Name WES HANIC

Reach Location Hampton Corner / Rt 202

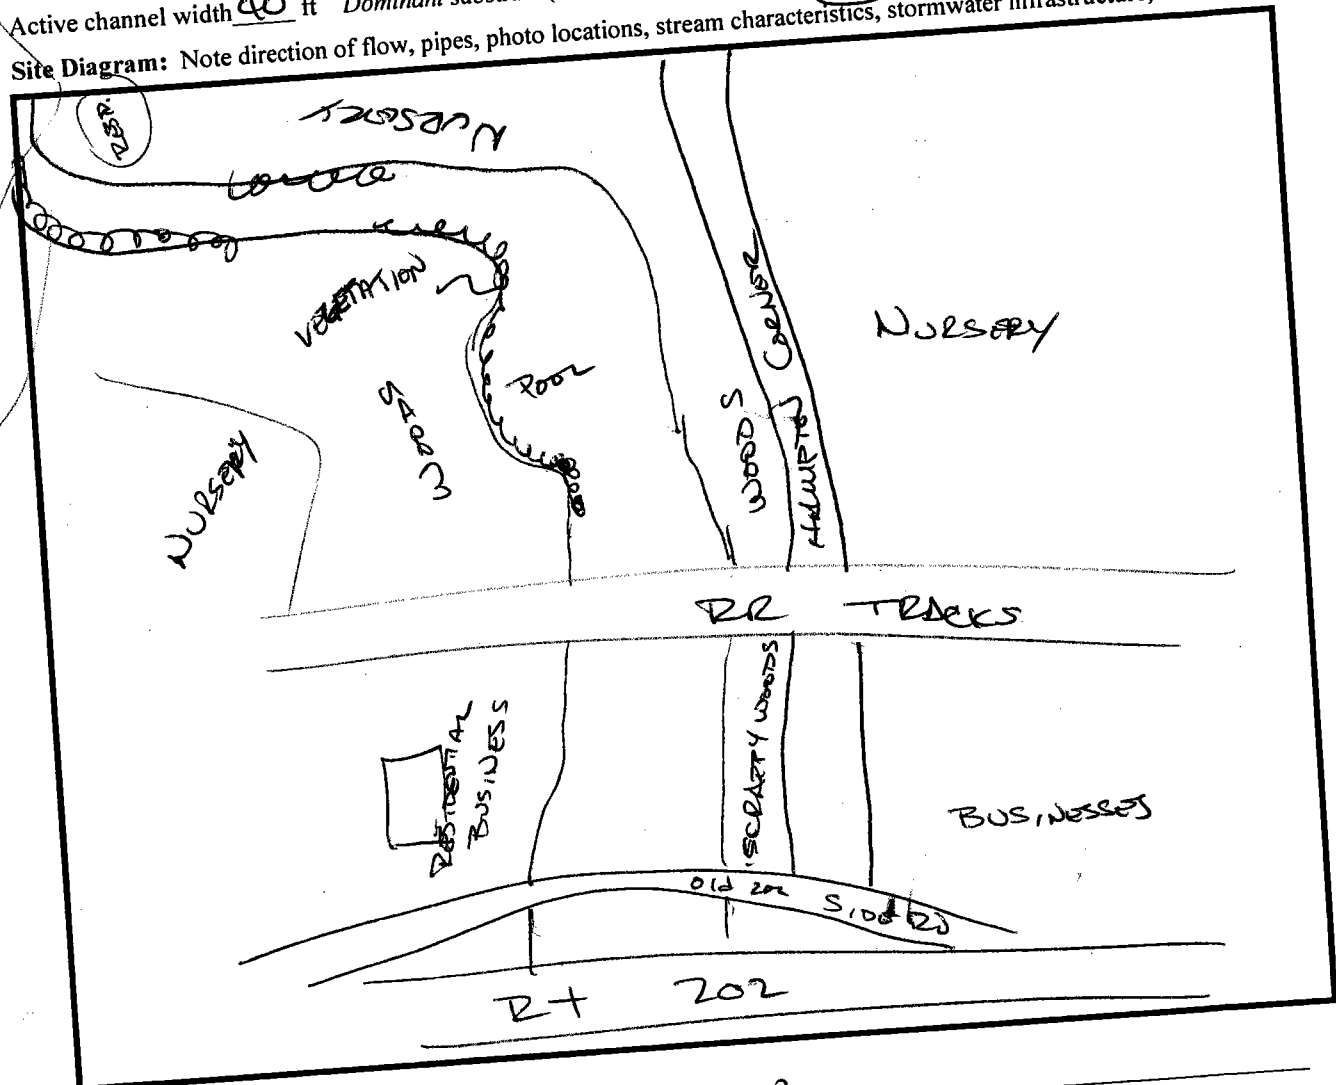
Debris, trash, litter?
Yes, lots

Comments & Suggestions:
Do you have suggestions for remediation along this reach?
Reconnect to floodplain

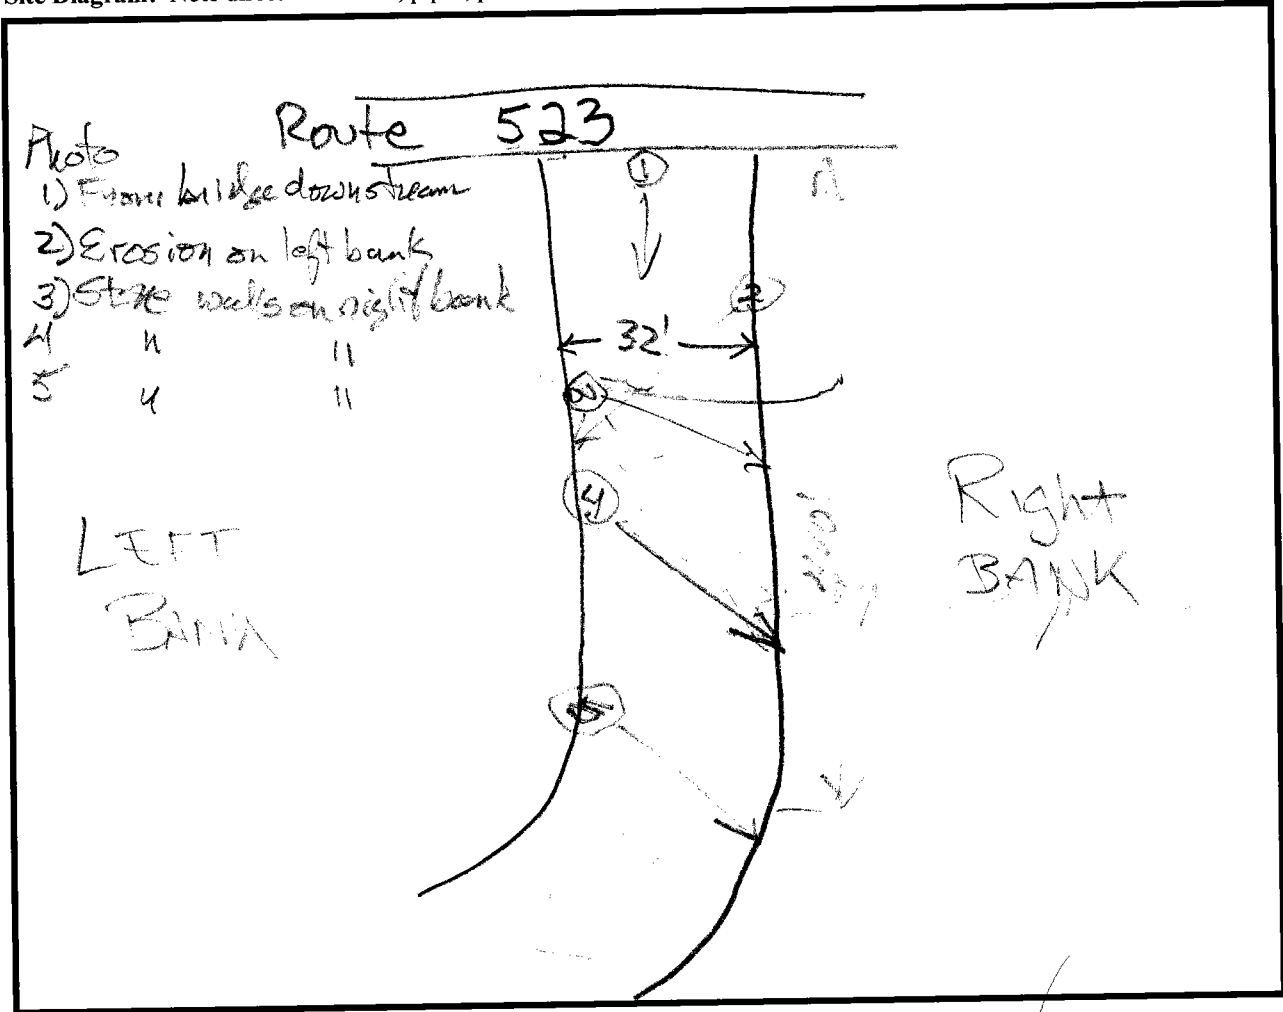
| 1. D/S from 523 bridge | 2. L/B erosion |
| 3. R/B Rock wall | 4. R/B Rock wall |
| 5. R/B Rock wall at river bend | 6. _____ |

Considerably altered by channeling walls

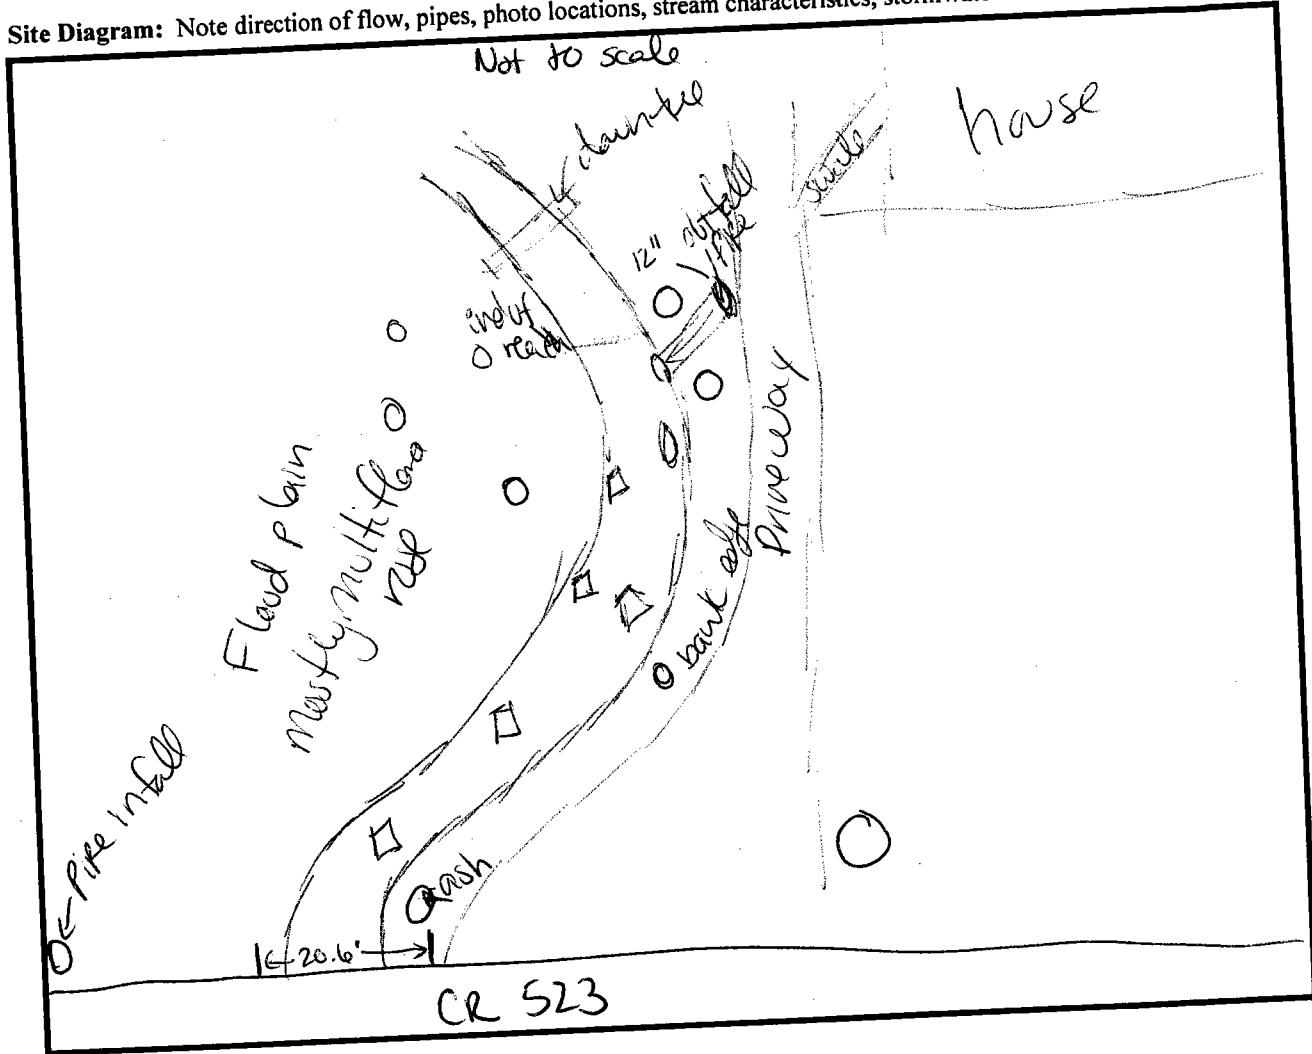
Instream fish cover *Culvert narrows to 3" wide* 8

pipe decaying

The stream corridor is in good shape. It looks like there was historic downcutting but the stream is stable now. Left bank is undercutting slightly with some roots exposed.

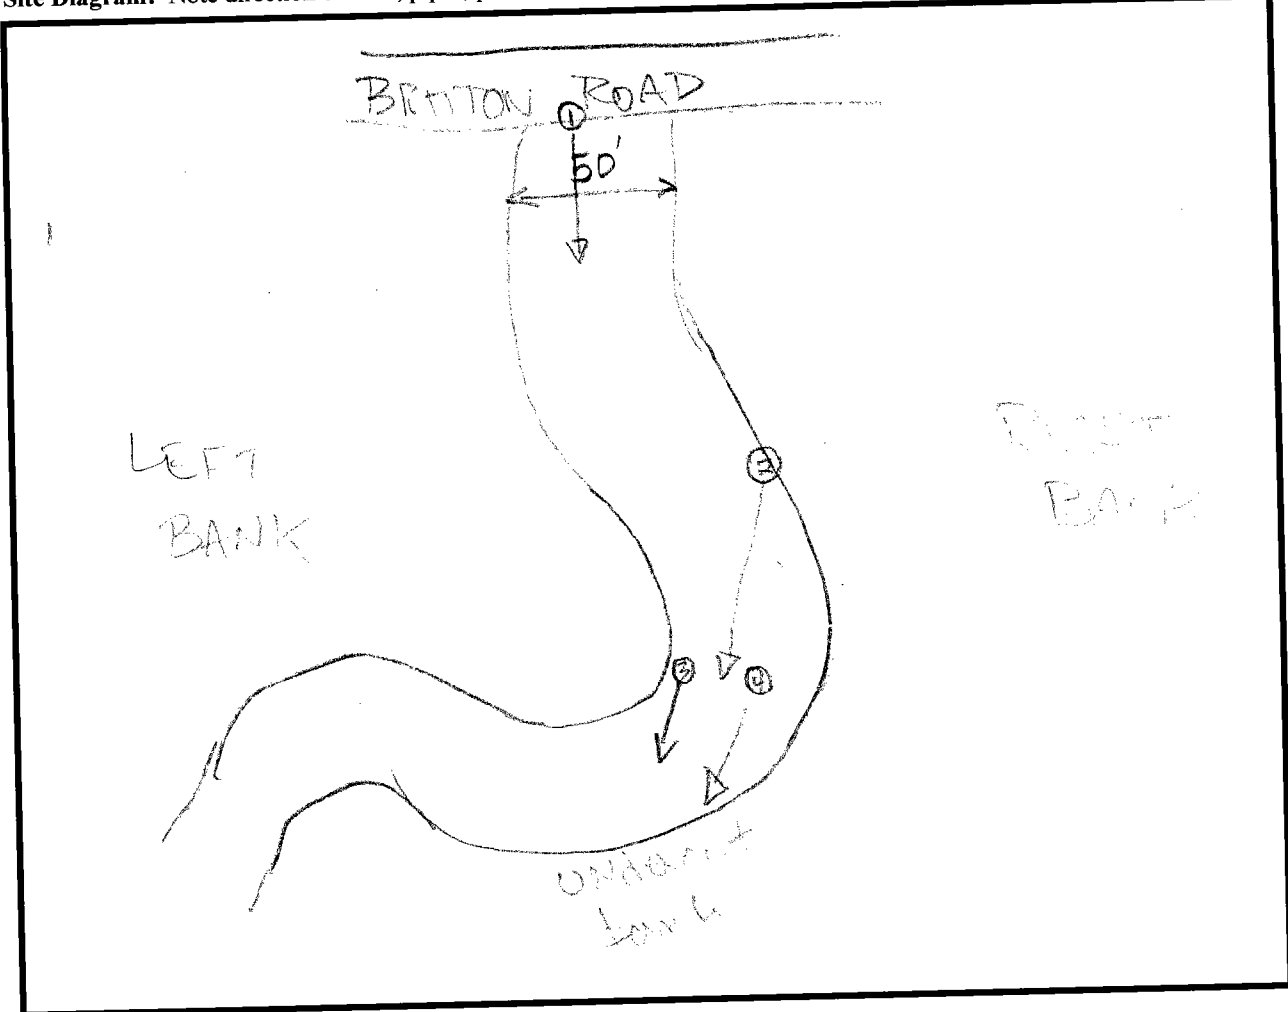
| 1. D/S from Britton Rd | 2. undercut bank |
| 3. undercut bank | 4. undercut bank |

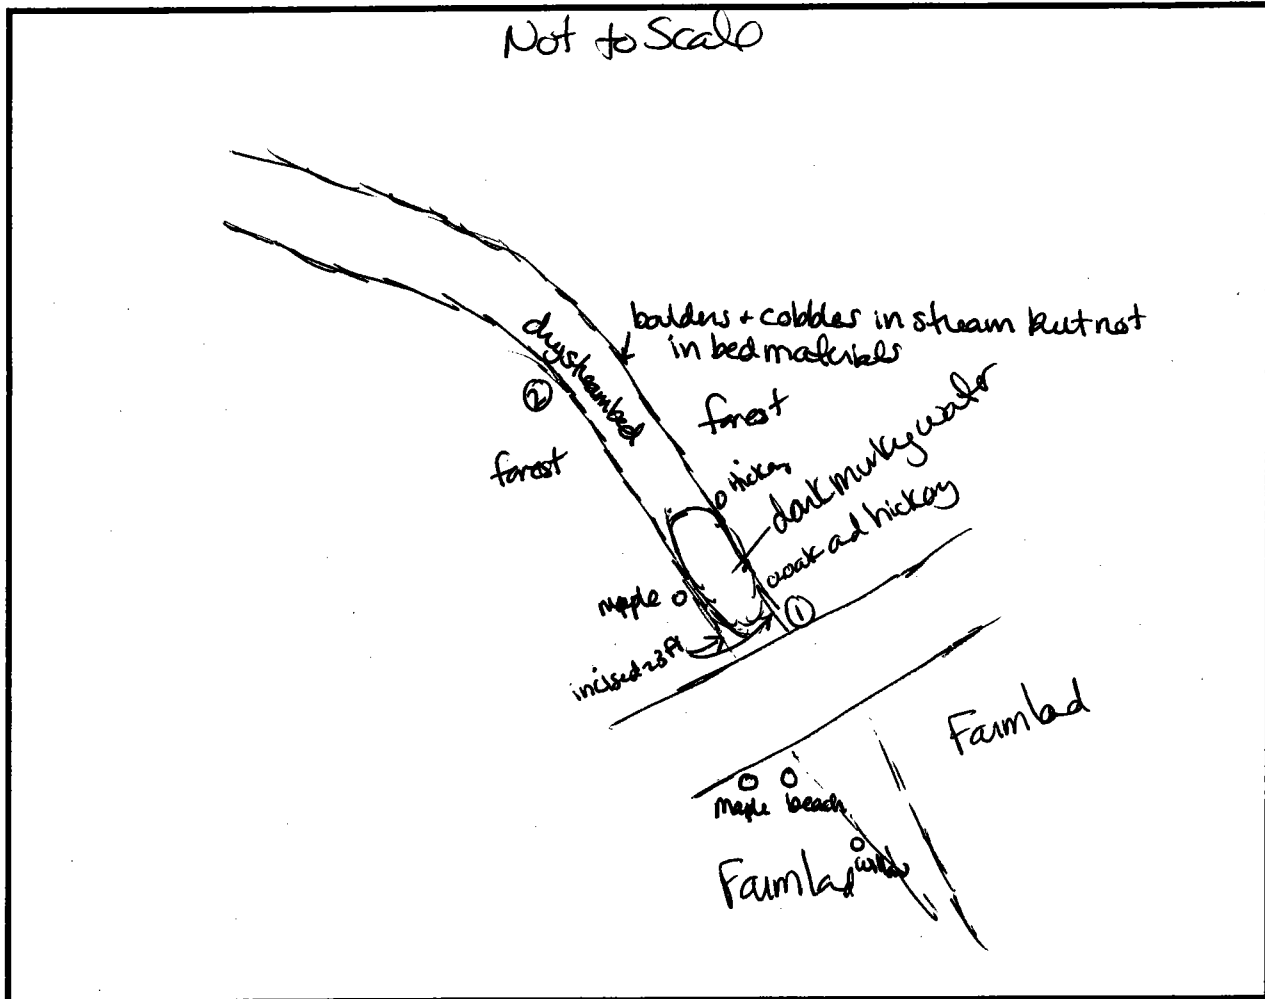
- Photo Notes: 1. Downstream from road crossing 2. upstream
3. _____ 4. _____
5. _____ 6. _____
7. _____ 8. _____
9. _____ 10. _____

Culvert appears to be promoting incision downstream of the road crossing. Culvert is 48 inches in diameter and 32 feet long. Suggest replacement w/ open bottom culvert when necessary
