Stream Visual Assessment Protocol

(Modified by the Rutgers Cooperative Extension Water Resources Program, www.water.rutgers.edu)

Stream Name Neshanic Grid ID A2-28

Stream Name Headquarters Trib Grid ID A2 - 28

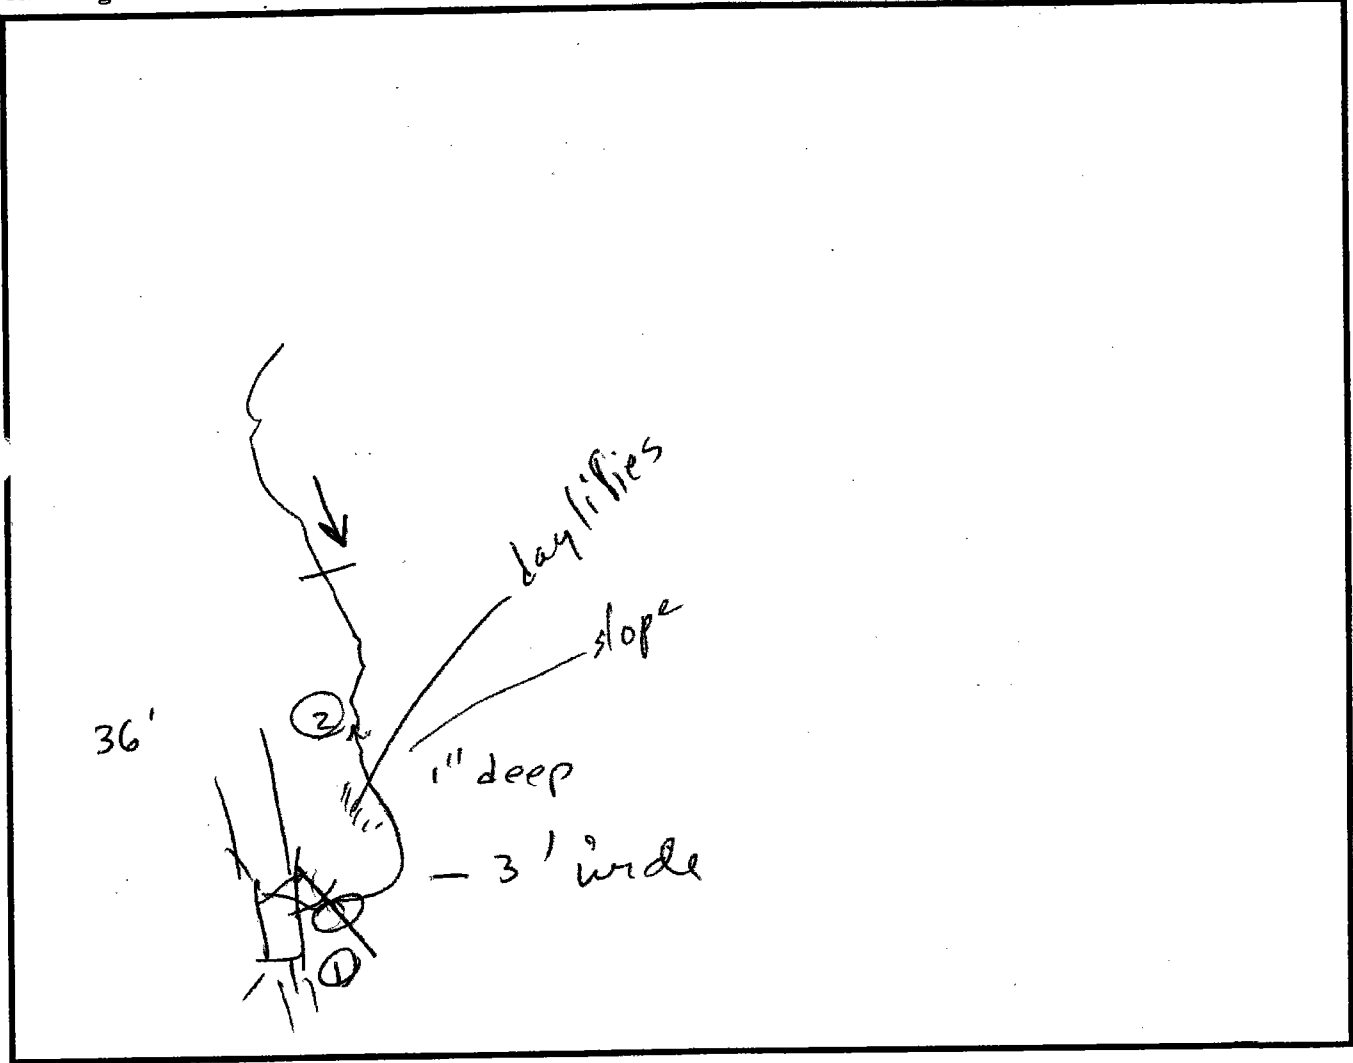
Site Diagram: Note direction of flow, pipes, photo locations, stream characteristics, stormwater infrastructure, & ditches.

| 1. <u>pool at bridge</u> | 2. <u>downstream at end of run</u> |
| 3. <u>entire run, downstream</u> | 4. _____ |

Overall Score 5.9 ~~6.9~~ $69 \div 12 = 5.75 < 6.0$ Poor
 (Total divided by number scored) 6.1-7.4 Fair
 Left: 5.9 Right: 5.9 Average: 5.9 7.5-8.9 Good
 > 9.0 Excellent

Do you have suggestions for remediation along this reach? so short, not worth effort

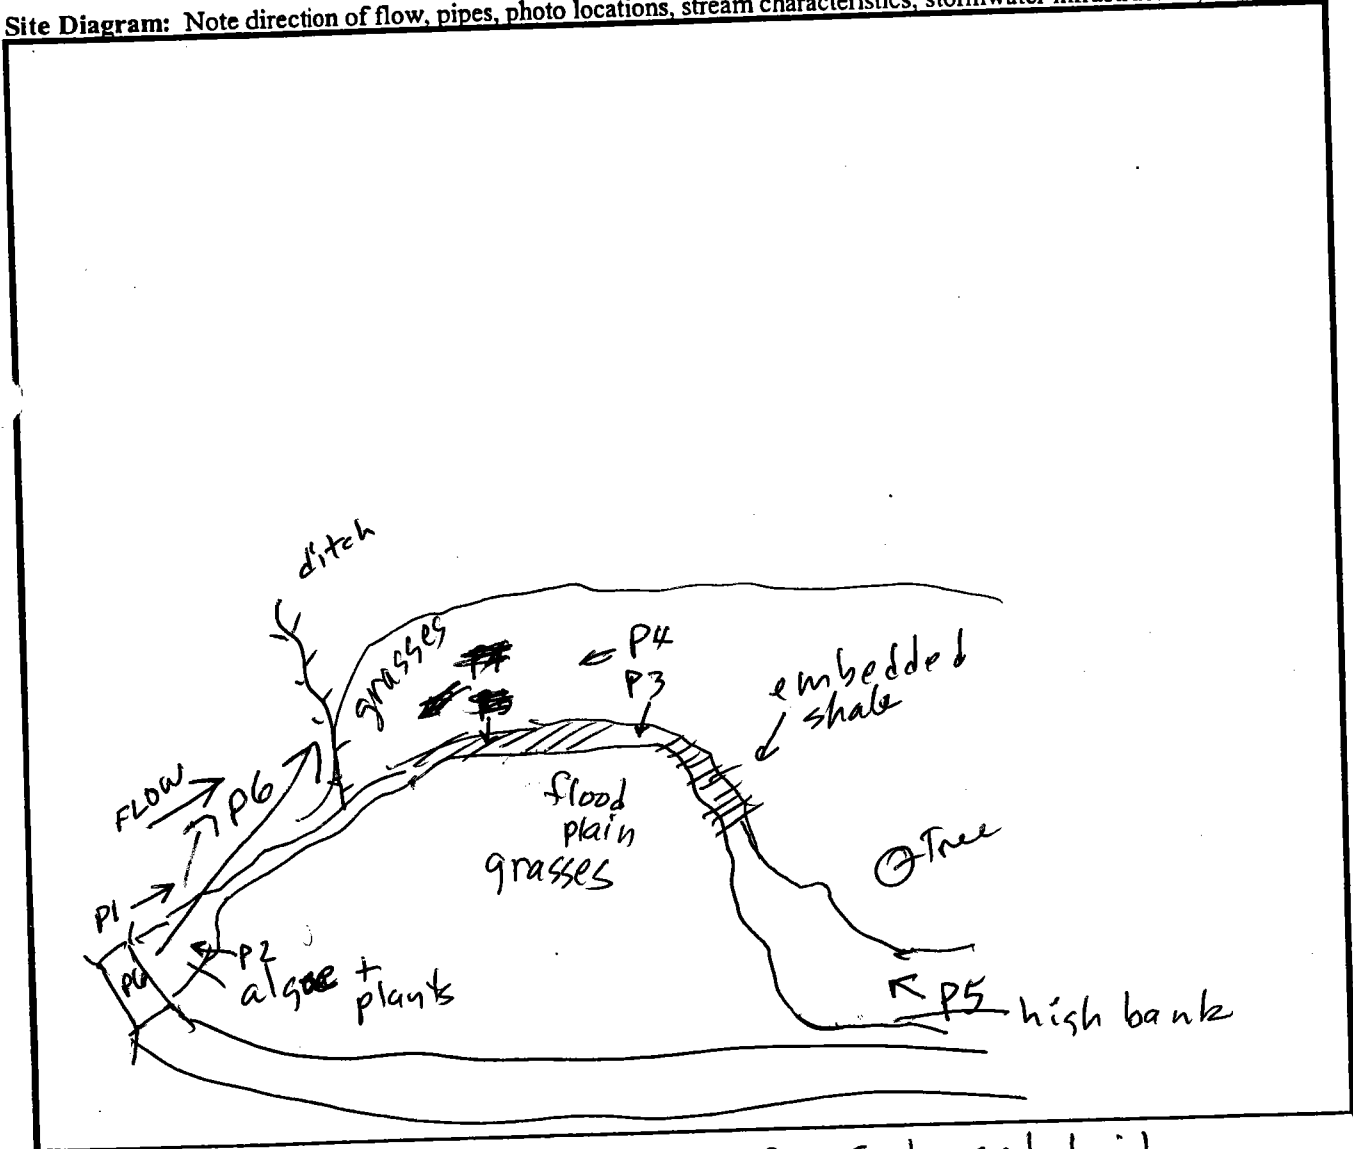
Site Diagram: Note direction of flow, pipes, photo locations, stream characteristics, stormwater infrastructure, & ditches.

| Photo Notes: 1. <u>DS from bridge</u> | 2. <u>US toward bridge</u> |
| 3. <u>Dead fish</u> | 4. <u>US from dead fish</u> |
| 5. <u>end of run / US</u> | 6. <u>bridge showing farm</u> |

Left: 6.6 Right: 6.7 Average: 6.65

some

Extend buffer by bridge

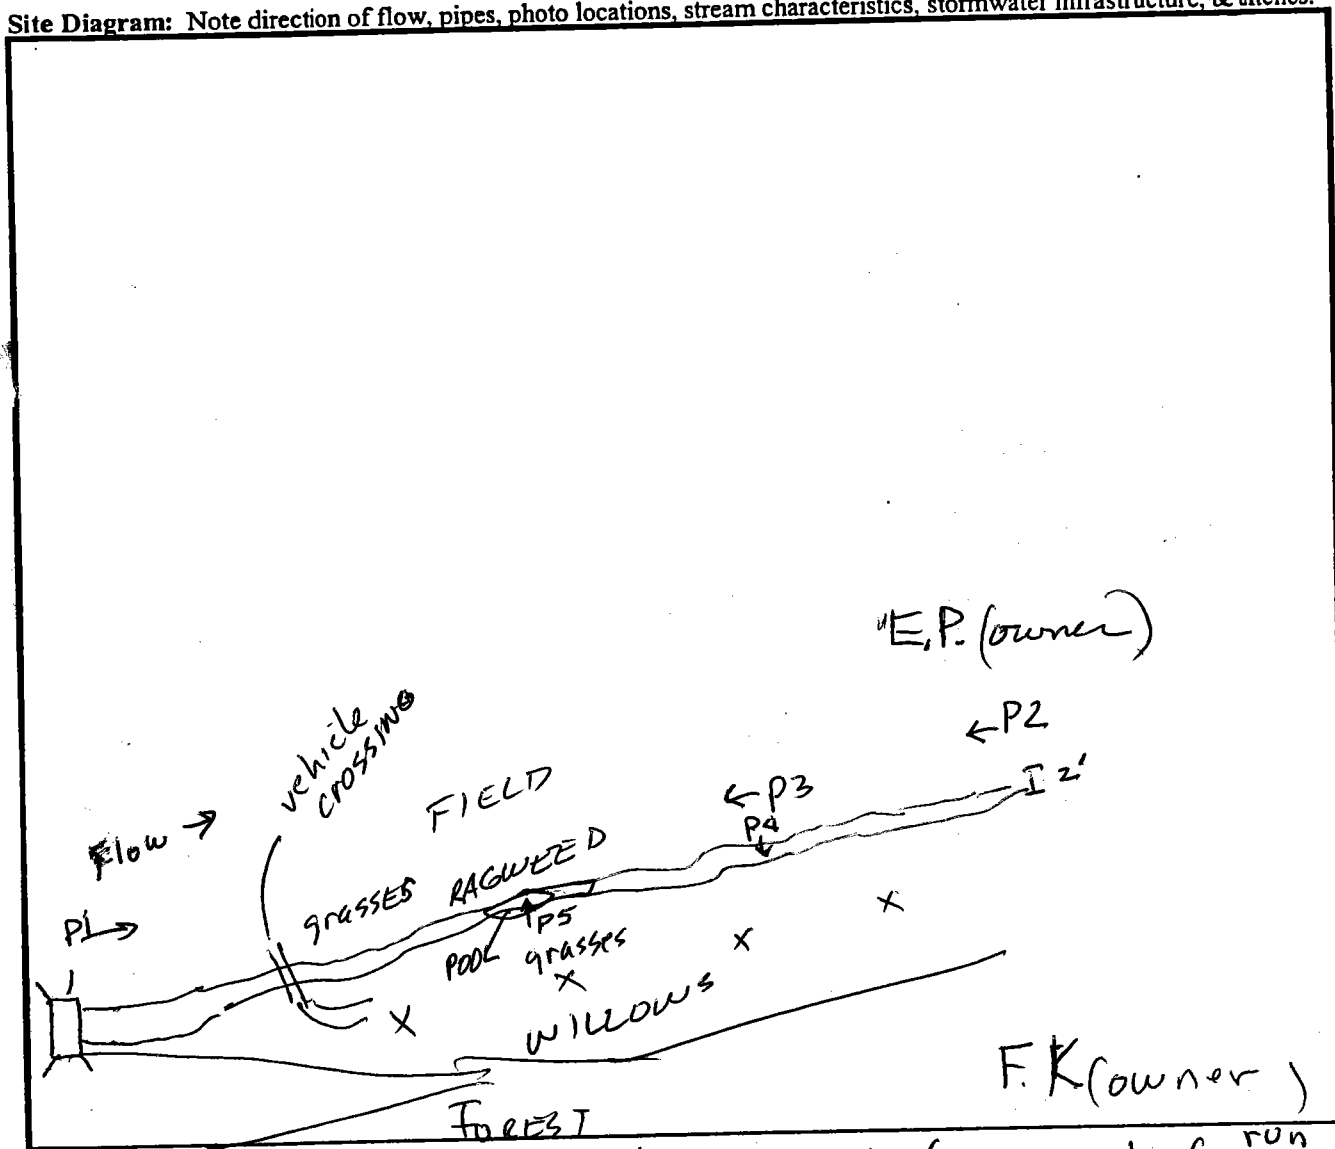
Site Diagram: Note direction of flow, pipes, photo locations, stream characteristics, stormwater infrastructure, & ditches.

| 1. DS from bridge | 2. US from end of reach |
| 3. Pool midway upstream | 4. Bottom of pool |
| 5. Bottom of pool | 6. _____ |

Overall Score L: 6.8 R: 5.2 < 6.0 Poor
 (Total divided by number scored) 6.1-7.4 Fair
 Left: ~~6.45~~ Right: ~~5.2~~ Average: ~~5.8~~ 7.5-8.9 Good
 7.1 5.7 6.0 > 9.0 Excellent

4x8 plywood

Stabilize right bank; ~~add~~ create riparian zone
Upstream; left bank, ...
Remove INVASIVES

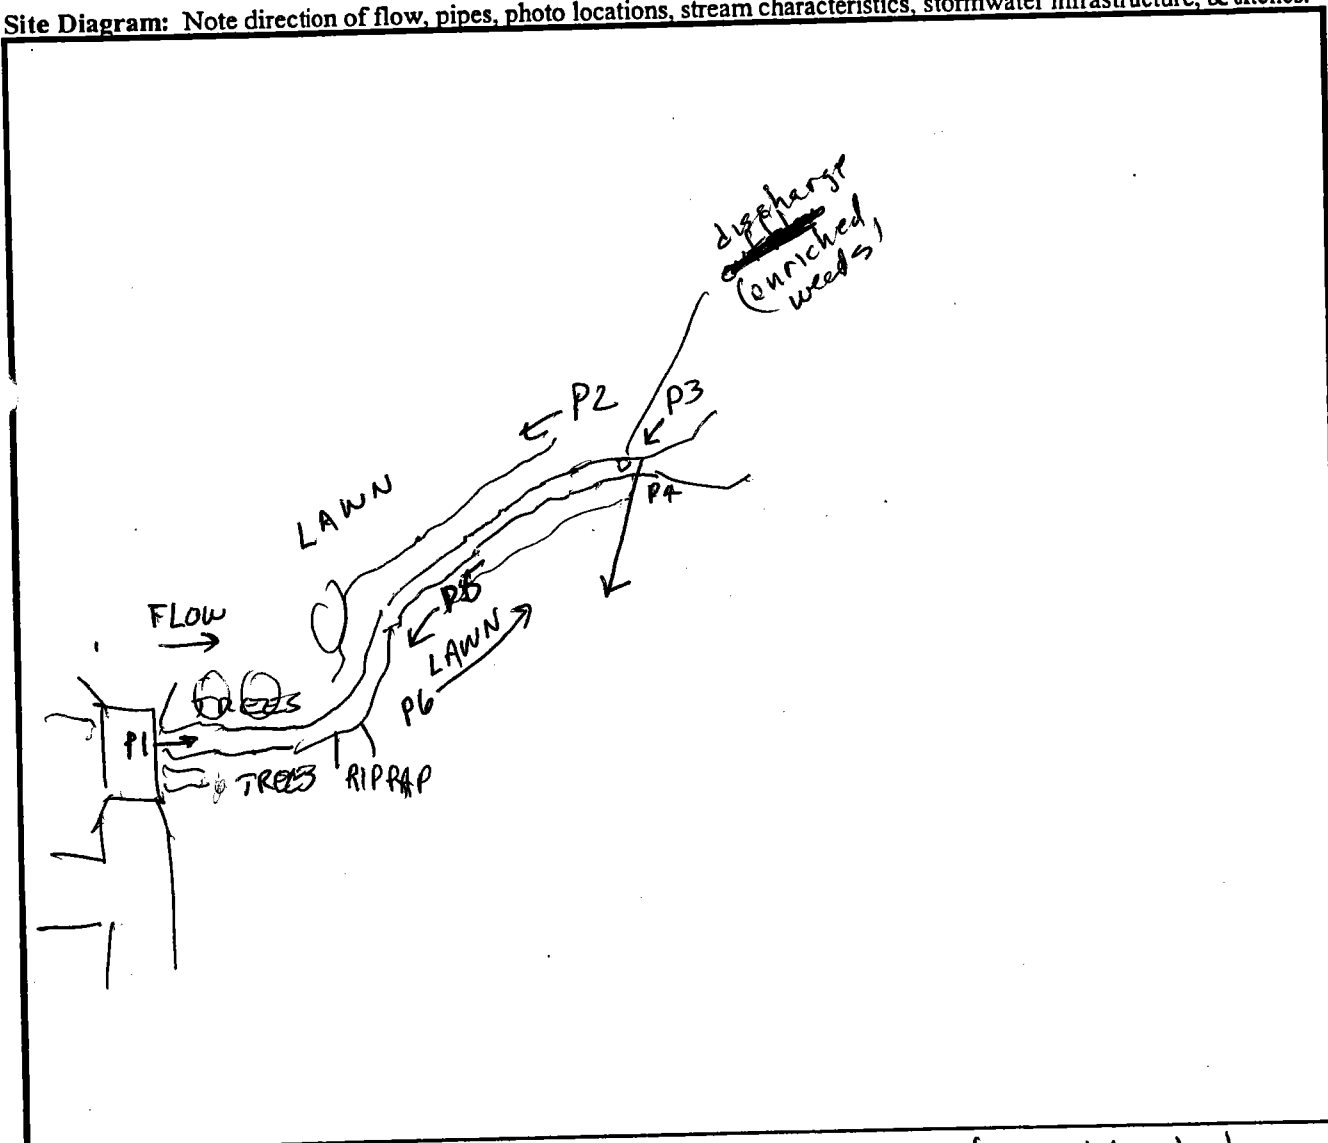
- Photo Notes:
1. DS from bridge
 2. US - pool with duckweed
 3. discharge pipe
 4. across at end of reach
 5. upstream at curve
 6. DS from curve w/ sign
 7. _____
 8. _____
 9. _____
 10. _____
