### Stream Visual Assessment Protocol

(Modified by the Rutgers Cooperative Extension Water Resources Program, [www.water.rutgers.edu](http://www.water.rutgers.edu))

Stream Name FIRST MESHANIC Grid ID D3

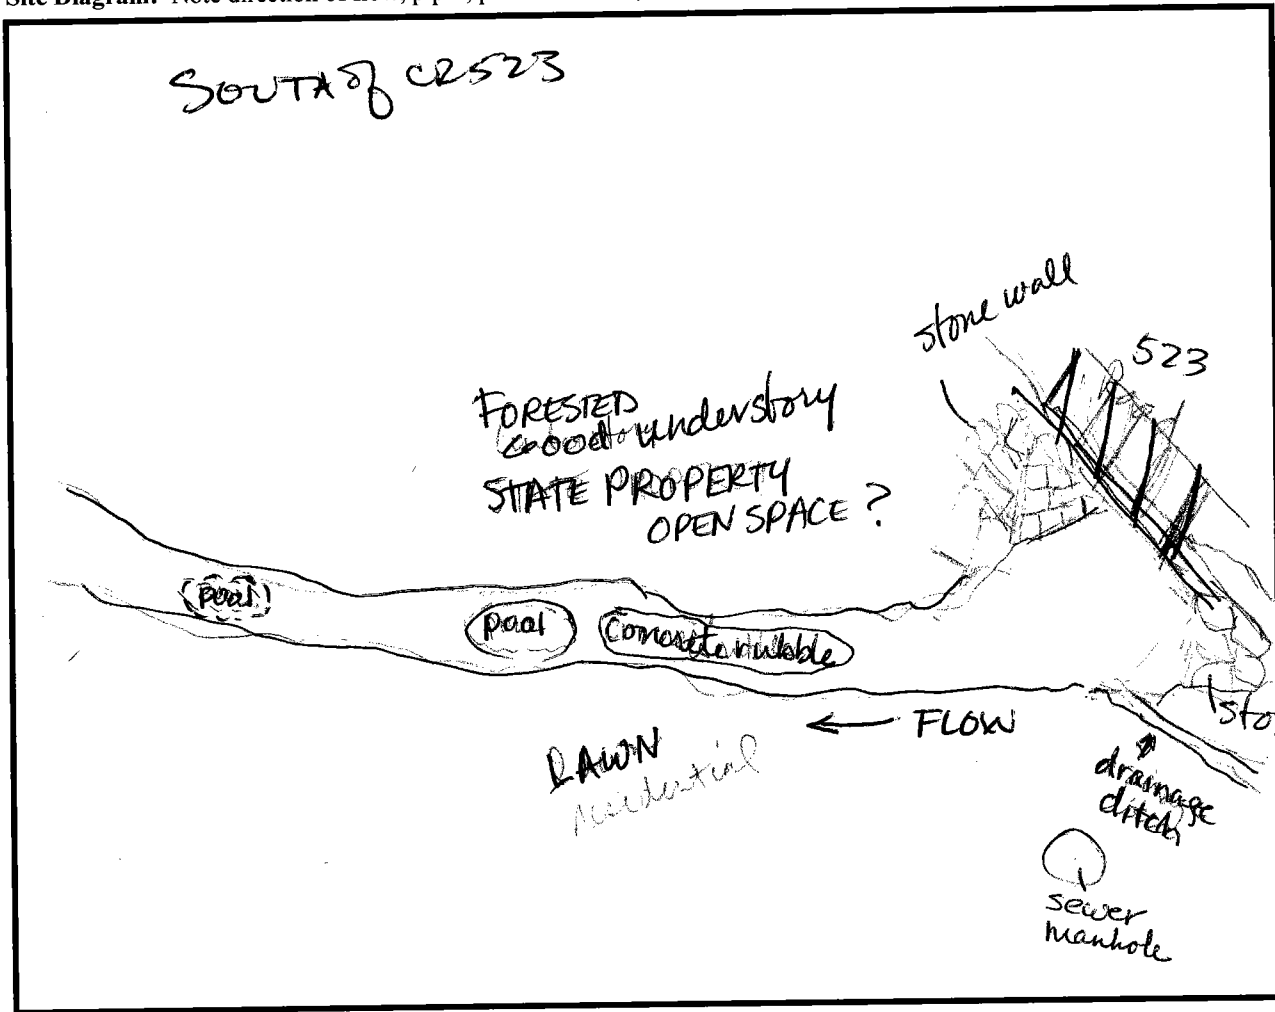
Site Diagram: Note direction of flow, pipes, photo locations, stream characteristics, stormwater infrastructure, & ditches.

MAY BE BACKWARDS

YES - CONCRETE CHUNKS + PIECE OF PIPE IN STREAM -  
Neighbor reported that during floods, lots of rubble imbeds  
in this stretch - She + her husband remove it.  
Additional comments:

Adjacent neighbor reports during heavy rains ~~the~~ stream  
overflows her lawn up to 75 feet -

LEFT BANK COULD BE PLANTED WITH NATIVE  
VEGETATION - DRAINAGE DITCH NEEDS TO BE DUG OUT  
TO PREVENT FLOODING TO LAWN

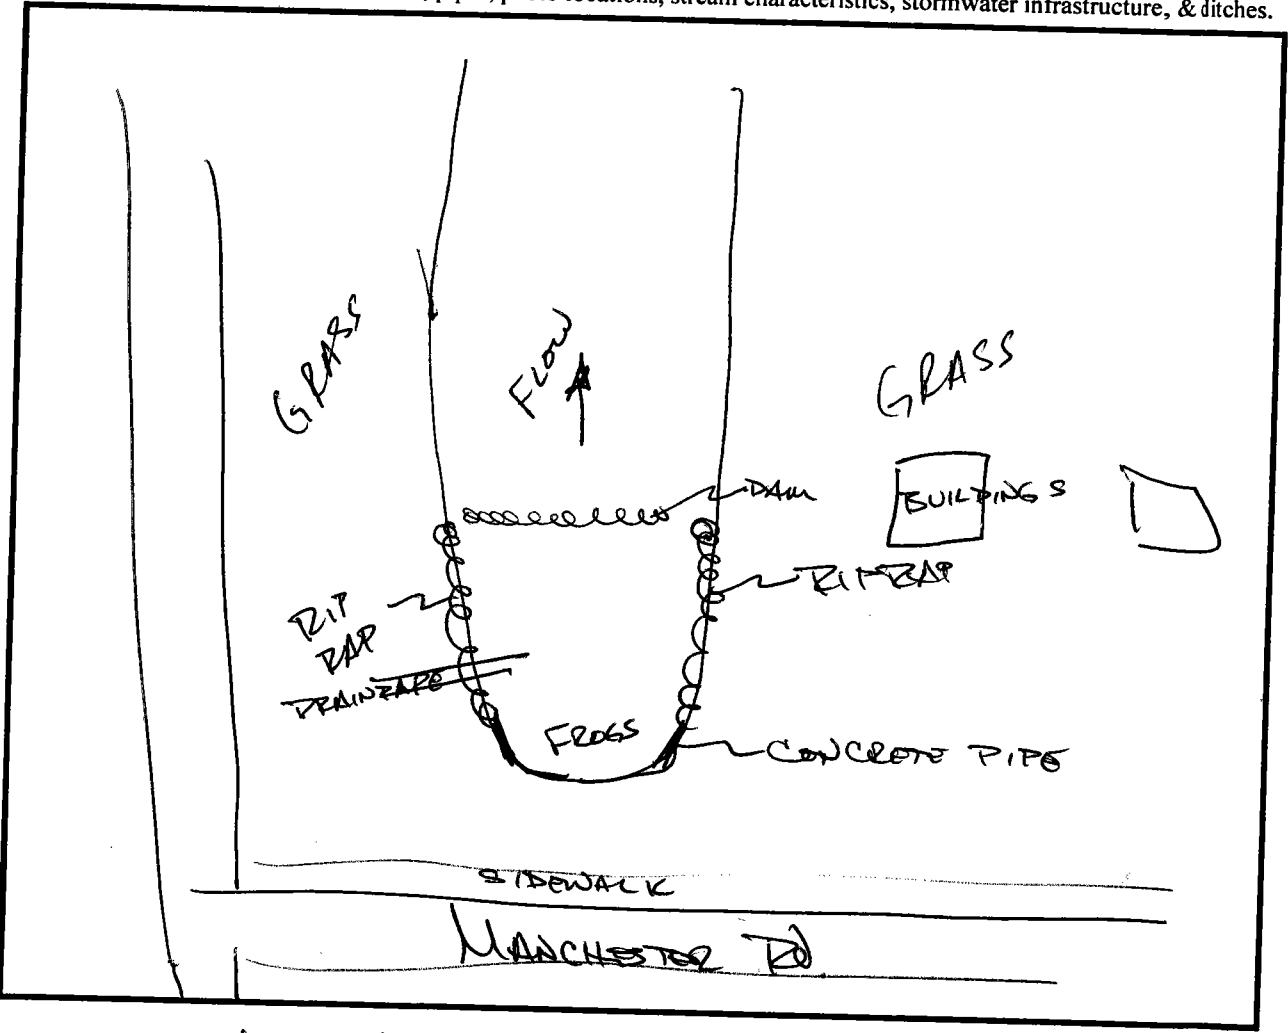
Site Diagram: Note direction of flow, pipes, photo locations, stream characteristics, stormwater infrastructure, & ditches.

- Photo Notes:
1. North of Manchester Rd
  2. South of Man. Rd. - DS
  3. DRAIN PIPE
  4. OUT LET
  5. STORM DRAIN on Manchester
  6. \_\_\_\_\_
  7. \_\_\_\_\_
  8. \_\_\_\_\_
  9. \_\_\_\_\_
  10. \_\_\_\_\_

*Mosquito Breeding Ground*

*Create more natural situation*

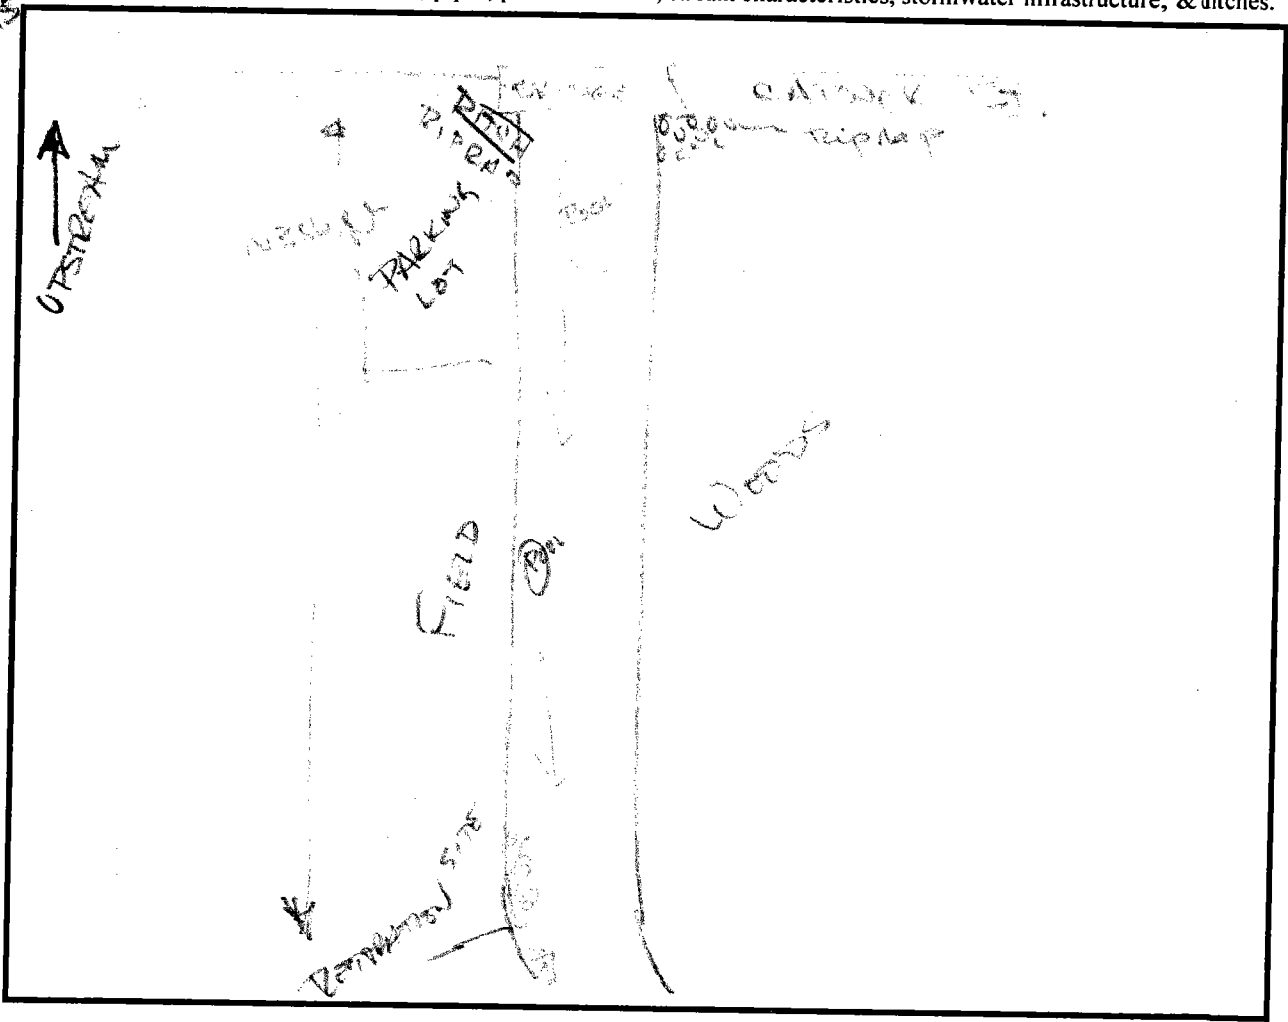
Site Diagram: Note direction of flow, pipes, photo locations, stream characteristics, stormwater infrastructure, & ditches.

Channel Condition *Jerry Poor* 1 *Riprap concrete walls*

planting + larger riparian buffer on left side
