THE NESHANIC RIVER WATERSHED RESTORATION AND PROTECTION PLAN

DATA SUMMARY – JULY 2007 BIOLOGICAL ASSESSMENT

Rutgers Cooperative Extension Water Resources Program

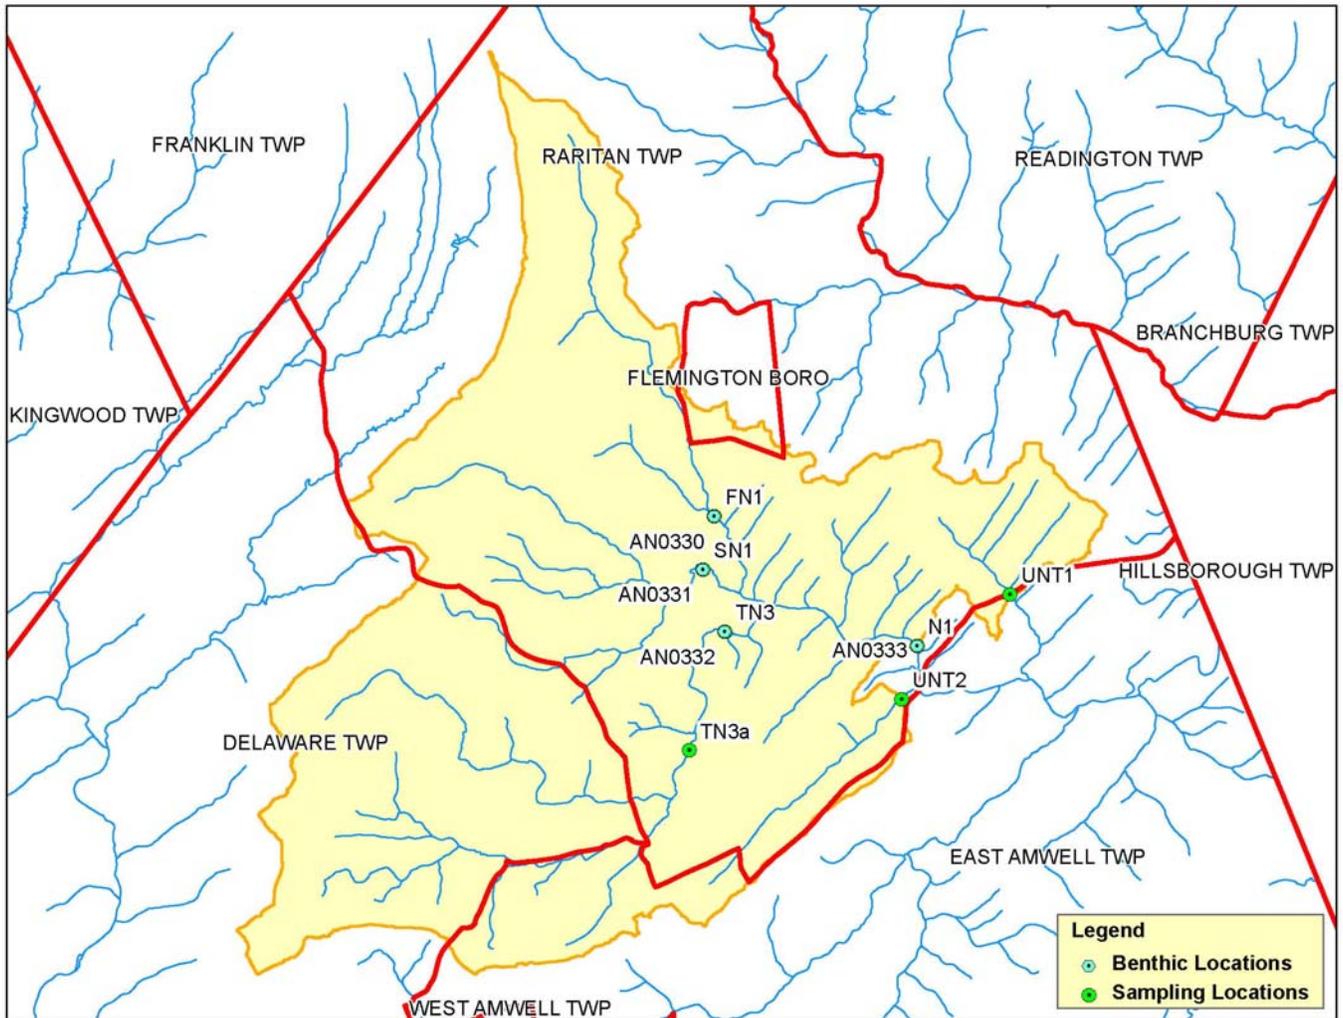
FIGURE 1. Sampling Locations

Rapid Bioassessment Protocol (RBP) procedure used by the NJDEP Bureau of Freshwater and Biological Monitoring, which is based on USEPA's *Rapid Bioassessment Protocols for Use in Streams and Wadeable Rivers* ((Barbour et al., 1999). Benthic macroinvertebrates were collected at four locations as described below and identified in Figure 1

Station	Description	Coordinates
FN1	First Neshanic River at Route 202 crossing; AMNET #AN0330	N40°29.400' W74°51.761'
SN1	Second Neshanic River at Route 202 crossing; AMNET #AN0331	N40°29.401' W74°51.763'
TN3	Third Neshanic River at Route 202 crossing; AMNET #AN0332	N40°28.484' W74°51.662'
N1	Neshanic River mainstem at Everitts Road and Reaville Road; AMNET #AN0333; USGS #01398000 (Neshanic River at Reaville, NJ)	N40°16.908' W74°47.253'

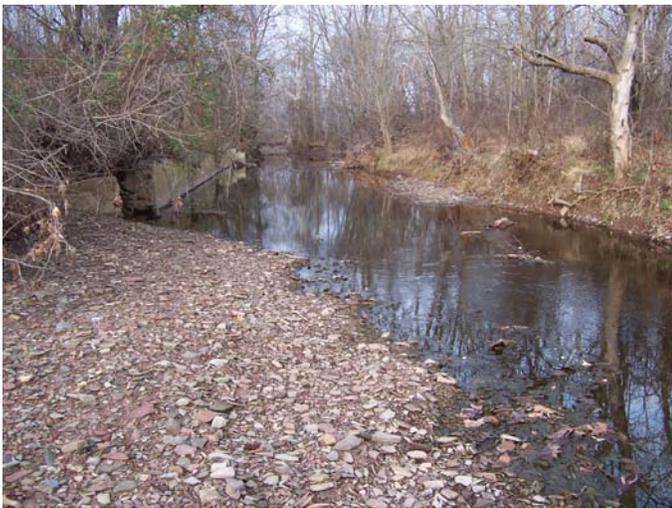
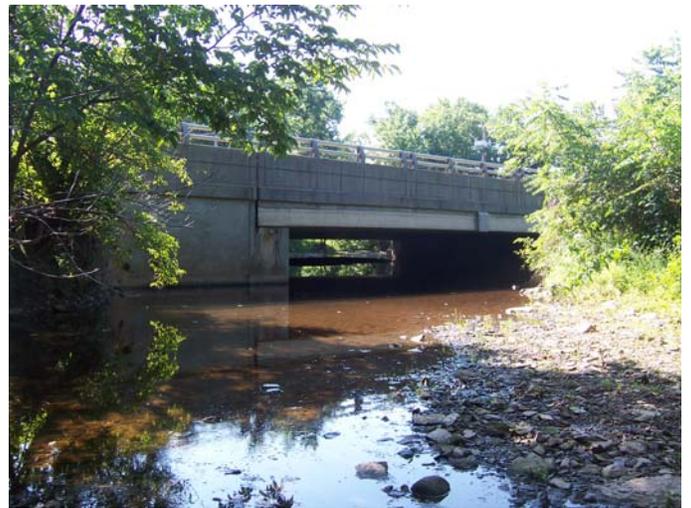
TABLE 5A. Calculation of Biological Condition for Station FN1

<i>Taxa</i>	<i>Tolerance Value</i>	<i>Station FNI Number of Individuals</i>
Planariidae	1	31
Gammaridae	4	2
Hydropsychidae	4	1
Leptoceridae	4	1
Philopotamidae	3	1
Elmidae	4	17
Chironomidae	6	42
Tipulidae	3	3
Taxa Richness		8
EPT Index		3
%CDF		43% Chironomidae
%EPT		3%
Family Biotic Index		3.87 very good water quality; possible slight organic pollution
NJIS Rating		15
Biological Condition		moderately impaired

The benthic macroinvertebrate community occurring within the vicinity of FN1 is apparently under some type of stress as evidenced by low taxa richness and poor representation of EPT taxa. Based on the calculated Family Biotic Index, the types of organisms found are indicative of very good water quality, but the index value suggests that there is possible slight organic pollution at the site (Hilsenhoff, 1988). In addition, the habitat assessment revealed marginal habitat conditions at FN1, which may also account for the impaired condition of the benthic macroinvertebrate community at this site. Also, although N1 was assessed as being non-impaired, the calculated Family Biotic Index was indicative of fairly poor water quality. The community at N1 may also be stressed.

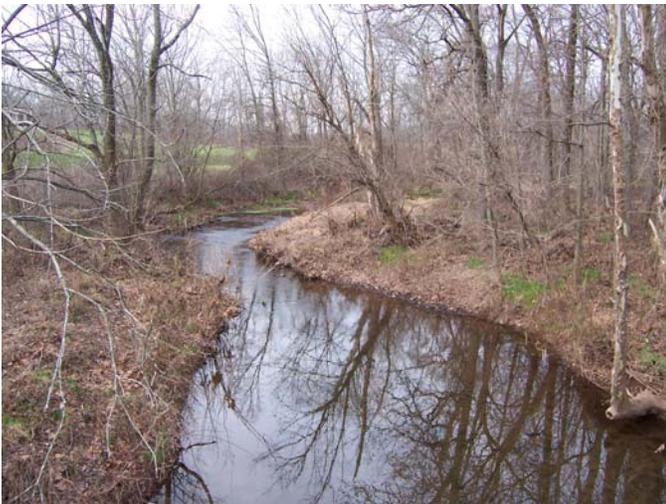
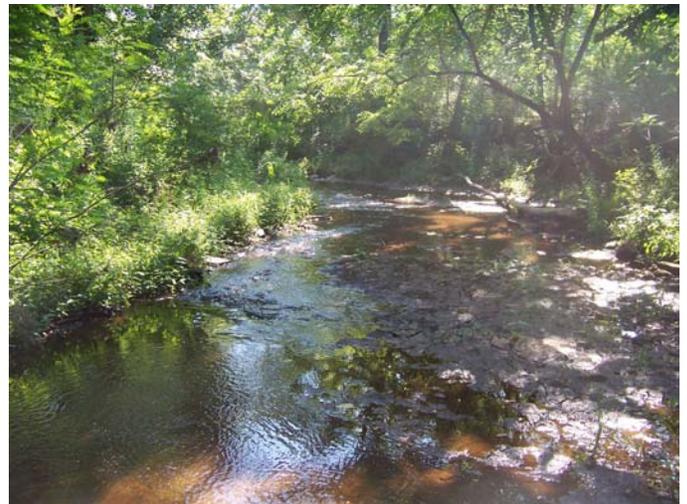
TABLE 5B. Calculation of Biological Condition for Station SN1

<i>Taxa</i>	<i>Tolerance Value</i>	<i>Station SNI Number of Individuals</i>
Planariidae	1	21
Gammaridae	4	2
Baetidae	4	1
Heptageniidae	4	2
Veliidae	8	1
Hydropsychidae	4	23
Elmidae	4	35
Gyrinidae	4	1
Psephenidae	4	18
Scirtidae	5	1
Chironomidae	6	3
Tipulidae	3	1
Taxa Richness		12
EPT Index		3
%CDF		32% Elmidae
%EPT		24%
Family Biotic Index		3.51 excellent water quality; organic pollution unlikely
NJIS Rating		24
Biological Condition		non-impaired

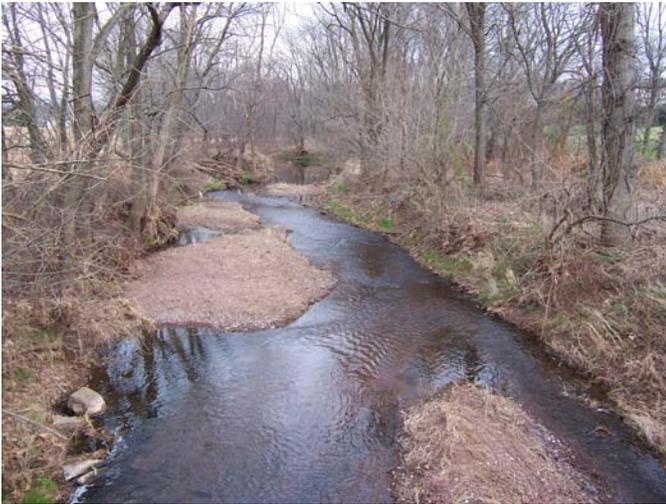
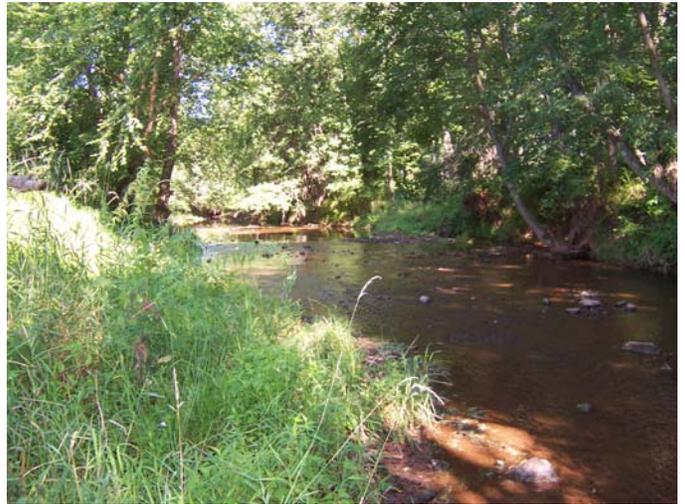
TABLE 5C. Calculation of Biological Condition for Station TN3

<i>Taxa</i>	<i>Tolerance Value</i>	<i>Station TN3 Number of Individuals</i>
Planariidae	1	13
Physidae	8	1
Gammaridae	4	1
Baetidae	4	2
Heptageniidae	4	3
Hydropsychidae	4	30
Philopotamidae	3	20
Elmidae	4	21
Gyrinidae	4	3
Psephenidae	4	4
Tipulidae	3	4
Taxa Richness		11
EPT Index		4
%CDF		29% Hydropsychidae
%EPT		54%
Family Biotic Index		3.42 excellent water quality; organic pollution unlikely
NJIS Rating		24
Biological Condition		non-impaired

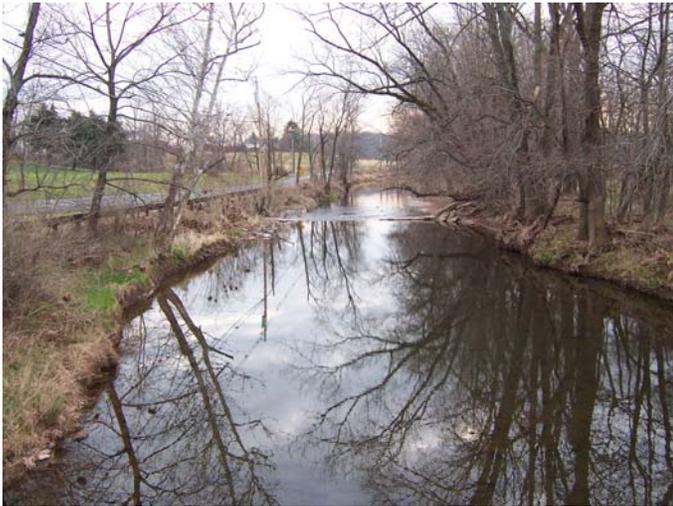
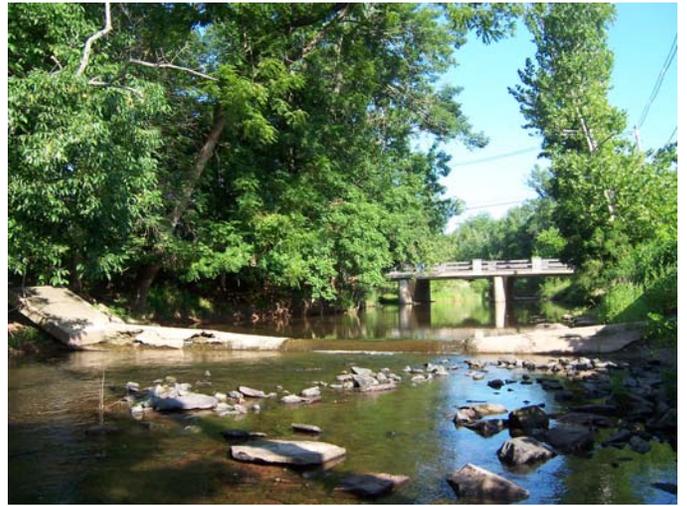
TABLE 5D. Calculation of Biological Condition for Station N1

<i>Taxa</i>	<i>Tolerance Value</i>	<i>Station N1 Number of Individuals</i>
Physidae	8	27
Planorbidae	8	16
Sphaeriidae	7	2
Gammaridae	4	4
Baetidae	4	3
Caenidae	7	12
Heptageniidae	4	7
Coenagrionidae	9	2
Gomphidae	1	1
Sialidae	4	1
Hydropsychidae	4	5
Philopotamidae	3	2
Polycentropididae	6	2
Elmidae	4	13
Gyrinidae	4	2
Psephenidae	4	4
Taxa Richness		16
EPT Index		6
%CDF		26% Physidae
%EPT		30%
Family Biotic Index		6.17 fairly poor; substantial pollution likely
NJIS Rating		24
Biological Condition		non-impaired
