Neshanic River Watershed Restoration Plan

Stormwater Infrastructure Inventory

Final Report

Hunterdon County Soil Conservation District
Frenchtown, New Jersey

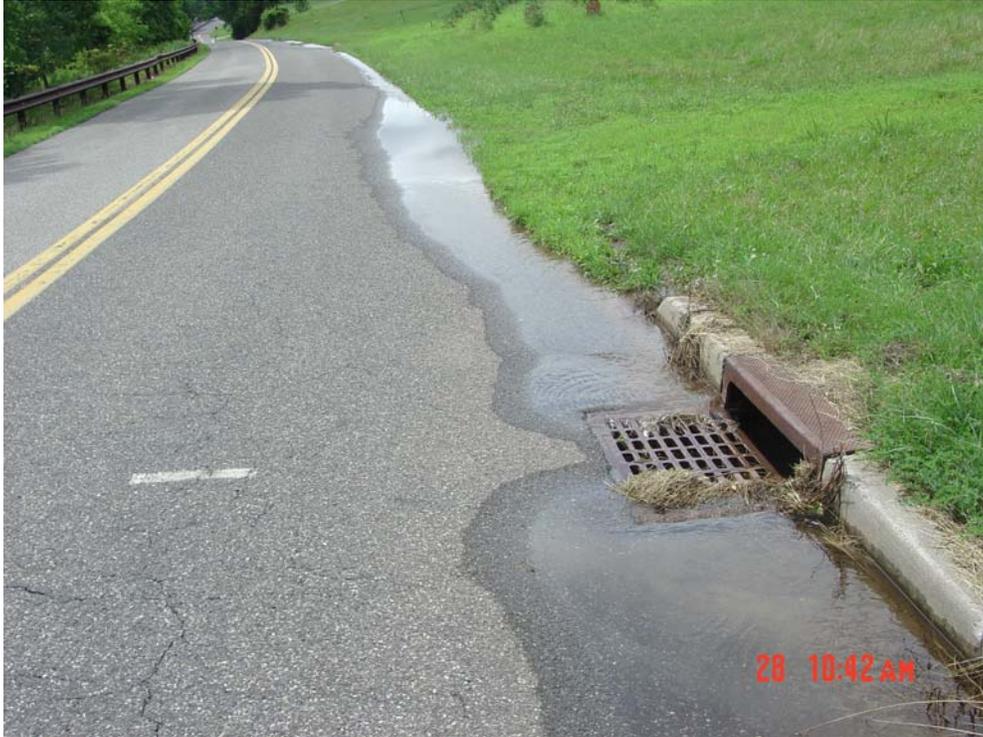
Figure 3: Catch Basin

Catch Basins Catch basins, also known as storm drain inlets, or curb inlets, are the primary collection points where stormwater enters into the municipal stormwater system. Catch basins are more prevalent in areas of newer or more urbanized infrastructure. Due to their relative similarity and the high number of catch basins, they were not individually photographed. A total of 4482 catch basins were located and mapped within the Neshanic River Watershed study area.

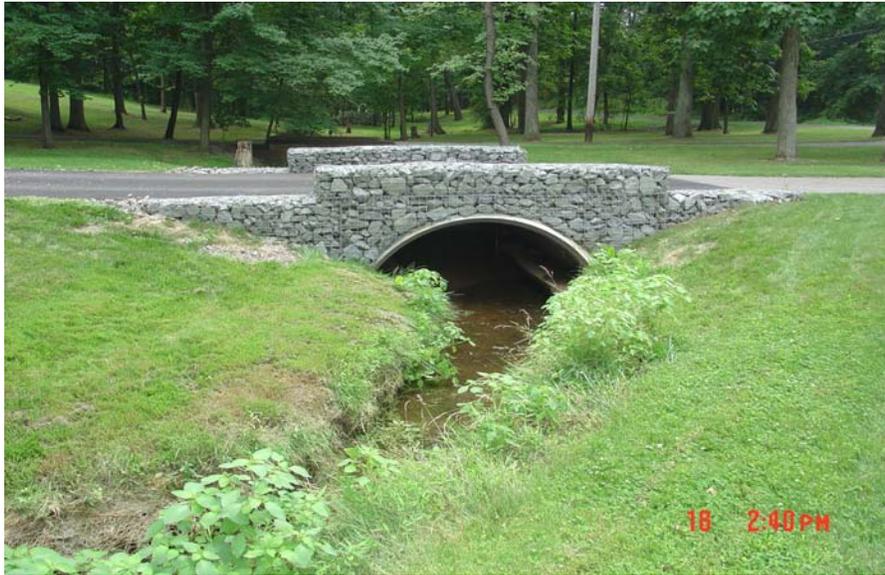
Figure 4: Culvert Down Stream

Culvert Downstream A culvert is a conduit used to enclose a concentrated flow. These are commonly employed to allow water to pass under a road, driveway, or railroad. The downstream portion of this feature signifies that this is the point at where water exits from the conduit. For the purpose of this study, culverts were defined as relatively straight segments – no turns, elbows, or bends. A total of 714 down stream culverts were mapped during the study

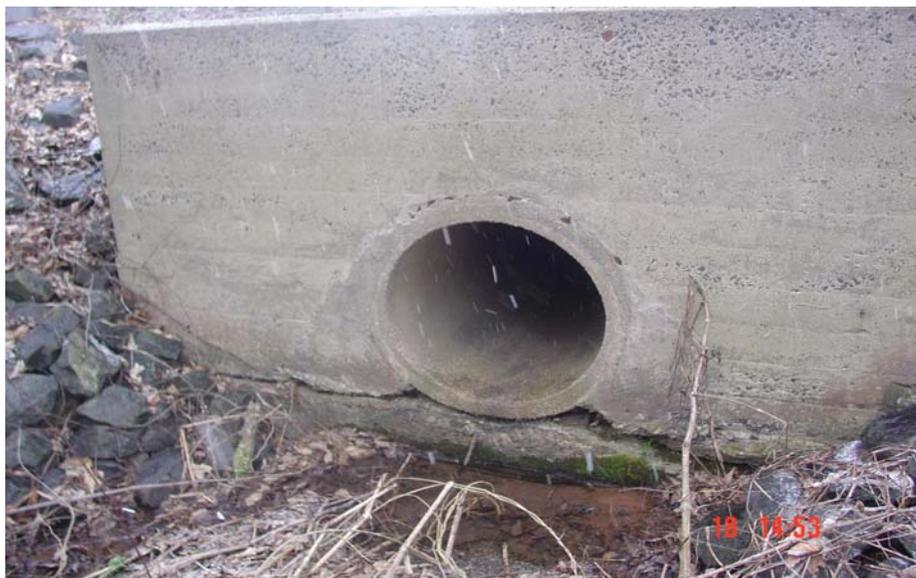
Figure 5: Discharge Pipe

Discharge pipes Also known as drainage pipes, or pipe outfalls, these are the locations where stormwater exits the stormwater system. Discharge pipes are most commonly located near streams, wetlands or other low lying areas. This category of feature does not include pipes which discharge directly into detention basins. Those features have been separated into their own class of features. A total of 409 discharge pipes were located in the study area.

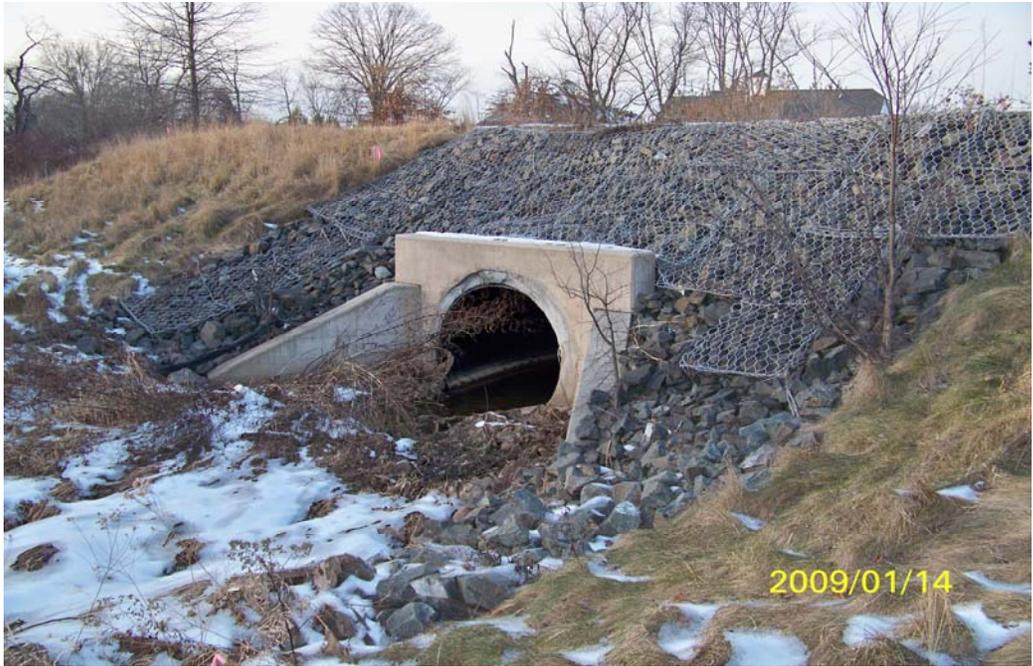
Figure 6: Detention Basin Discharge

Basin Discharges The point of discharge of a detention basin. These are commonly located in low area adjacent to streams or wetlands. A total of, 118 were mapped in the study area. Since some detention basins discharge back into the MS4 via subsurface piping not every basin had a basin discharge pipe.

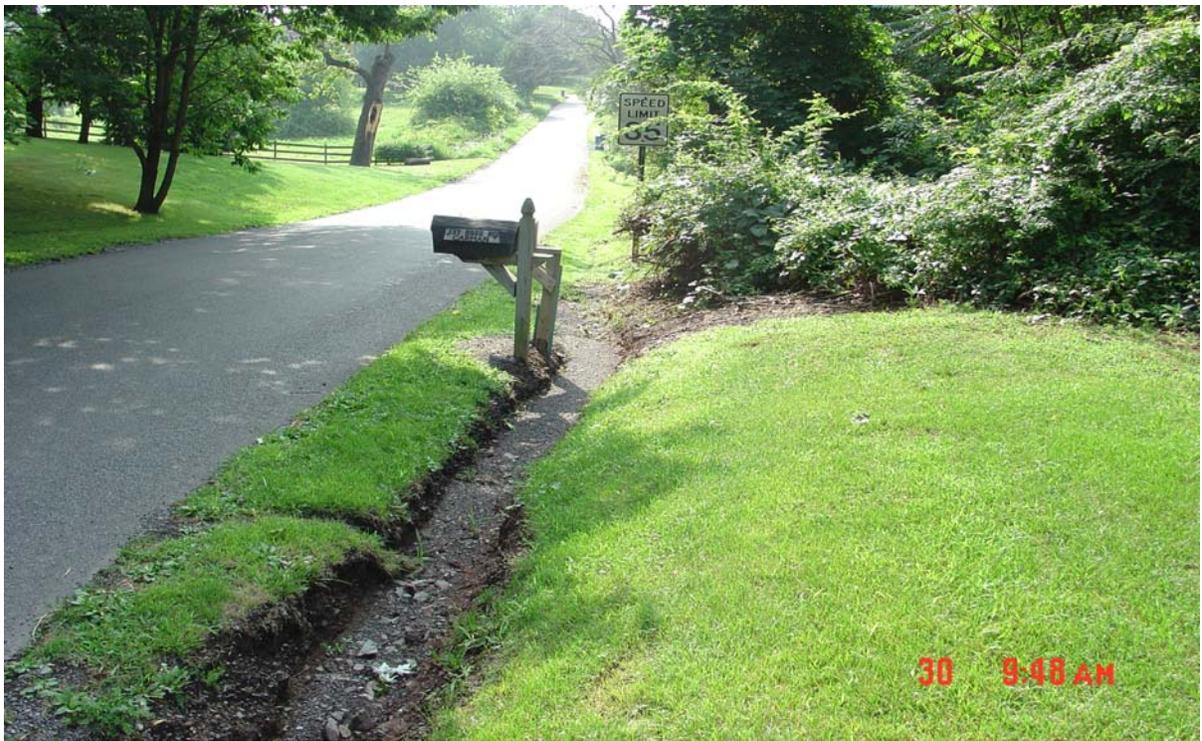
Figure 8: Roadside Swale

Ditches and Swales This category indicates the presence of defined flow paths used to direct stormwater flows. Swales and ditches are most common in the more rural portions of the watershed where piped drainage is less prevalent. A total of 853 swale /ditch segments were identified within the study area.

Swales and Ditches- Ideally a stormwater system should improve the quality of the water flowing through it. At the least, we should strive to have a conveyance system not degrade water quality by adding additional pollutants to the waters flowing through it. The ditch and swale system of the Neshanic River offers opportunities for improving both the design and maintenance of swales and ditches.

Of 853 (40.06 miles) mapped swale segments 185 (8.68 miles) were rated as being in urgent need of repair- these swales were actively eroding, thus contributing sediment to stormwater which flows through them. Of the 515 of 853 (25.81 miles) were rated as needing repair. In these swale segments water was permitted to flow over exposed earth in at least portions of conveyance. Only 153 (5.57 miles) of swale segments were found to be in good condition -consistent with the soil erosion standards for a grassed waterway or rip-rap channel. Swales in good condition should be expected to offer some water quality improvement, (Schueler, 1995) or again, not further degrade water quality by contributing additional loadings. Properly vegetated swales, with good maintenance regimes have been shown to promote recharge while reducing the volume, velocity and peak flows. (The Center for Neighborhood Technology, 2009)

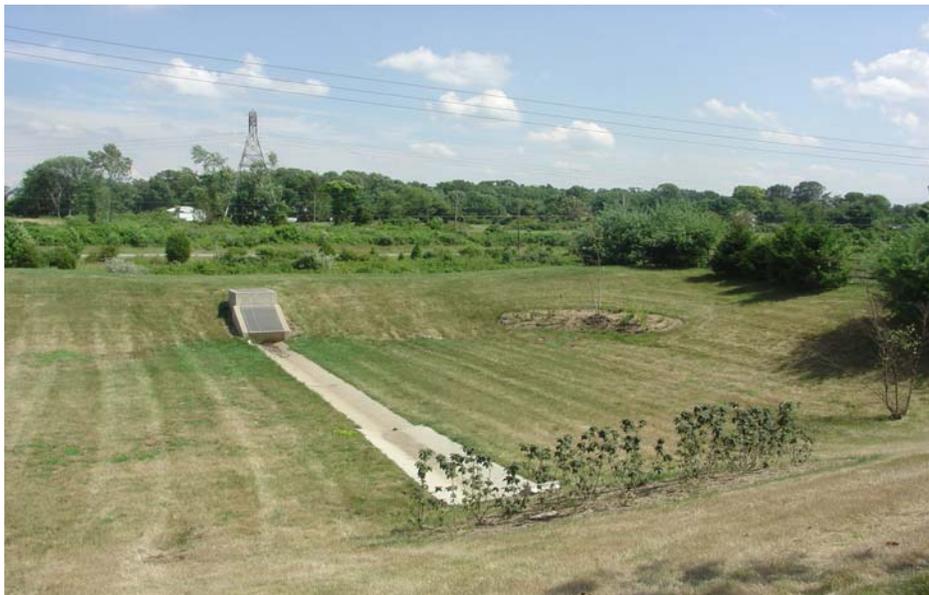
Figure 10: Detention Basin

Detention Basin Is a stormwater management facility. Typically these are constructed impoundments, but may also include bermed stream corridors. Originally these were constructed strictly to reduce flooding and to lower the volume and velocity of stormwater flows. In latter designs water quality enhancements have been included. The most common is the inclusion of a 3 inch water quality orifice which is designed to increase residency time and improve nutrient reductions. A total of 154 Detention Basins were located in the study area.

Detention Basins There are a variety of different detention basin designs in the Neshanic River Watershed. These include wet ponds, infiltration basins, bio-retention basins, extended dry detention basins, and even bermed off stream corridors with flow control weirs. Adding further diversity to the data set, there are a variety of maintenance levels ranging from heavily landscaped and manicured to benign neglect and outright abandonment. Virtually all of detention basins in the watershed present an opportunity for upgrades or retrofits.

- 106 of 155 basins were found to have mowed turf bottoms.
- 8 basins had weeds or successional vegetation due to a lack of mowing.

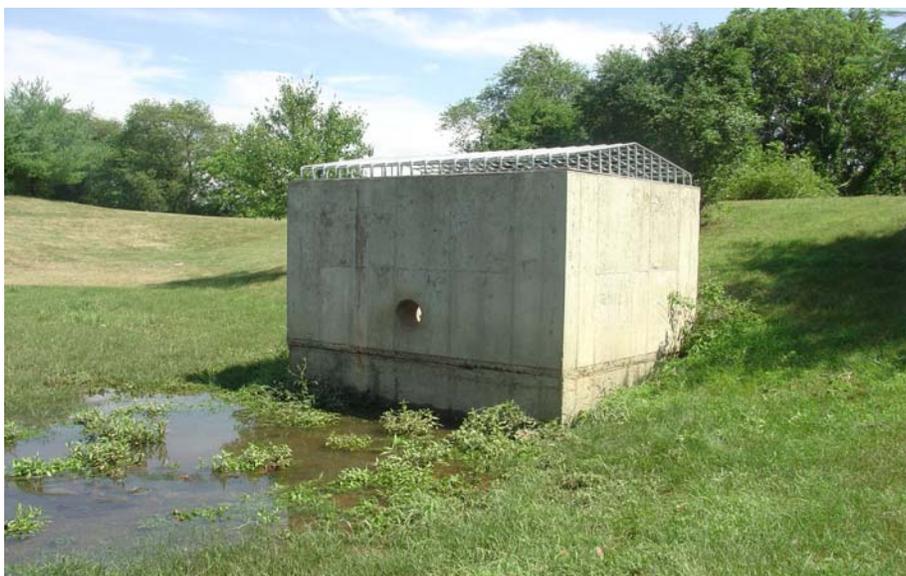
Figure 11: Detention Basin Outlet Structure

Basin Outlet Structure A structure designed to regulate stormwater flows exiting from a detention basin. These have grown in complexity over time. They range from simple concrete weirs regulating flows to complex multi outlet cast concrete towers weighing several tons. A total of 151 detention basin outlet structures were located in the study area.

- Low flow channels were very common in the watershed's detention basins. Of these, 156 of 196 low flow channel segments were found to be concrete.
- Greater than 1/3 of the (63 /151) detention basin outlet structures were found to have a three-inch water quality orifice. This indicates that 88 of the watershed's detention basins either were not constructed to achieve water quality through extended detention, or they achieve this through other designs.

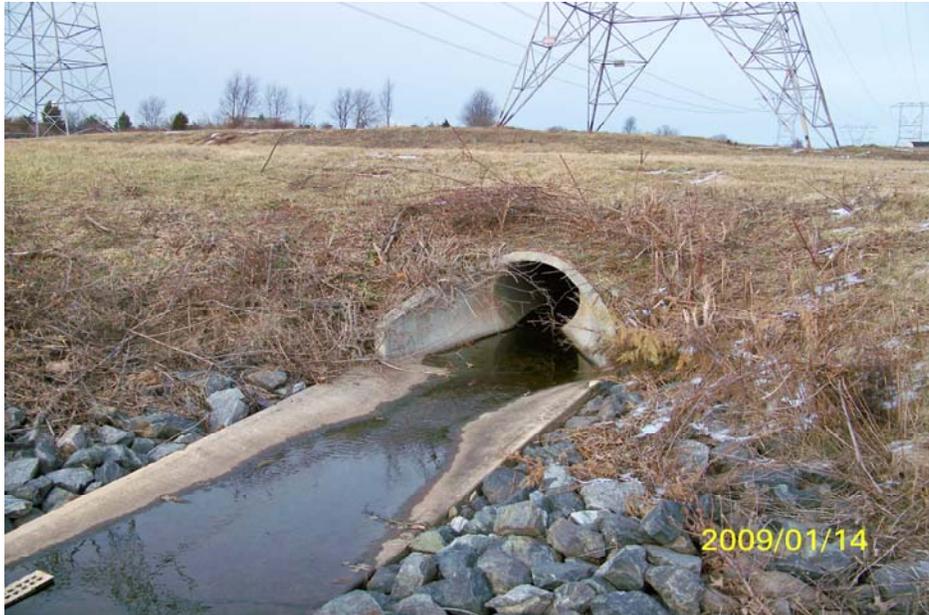
Figure 12: Detention Basin Inlet Pipe

Basin Inflows Are pipes which carry water into a detention basin. These are in effect discharge pipes which empty into a detention facility. While some basins rely strictly on overland flow to direct water to a detention basin, it is not uncommon for a single detention basin to have multiple inflow pipes. A total of 220 were basin inflow pipes mapped in the study area.

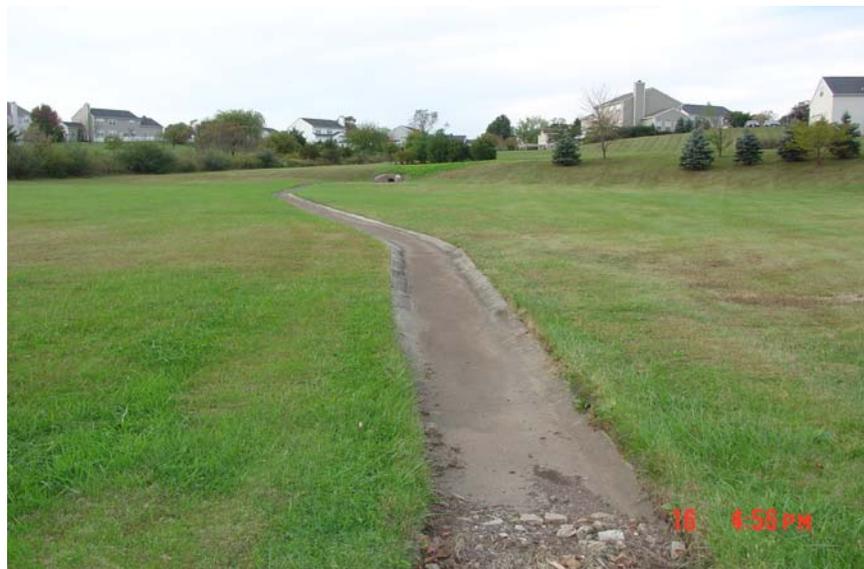
Figure 12: Detention Basin Low Flow Channel

Low Flow Channel – Are defined flow paths located on the floor of a detention basins. These features channel stormwater flows from a point of entry to the basins outlet structure or discharge point. Some basins have multiple channels while others do not have a low flow channel. A total of 196 separate low flow channel segments were located and mapped in the study area.

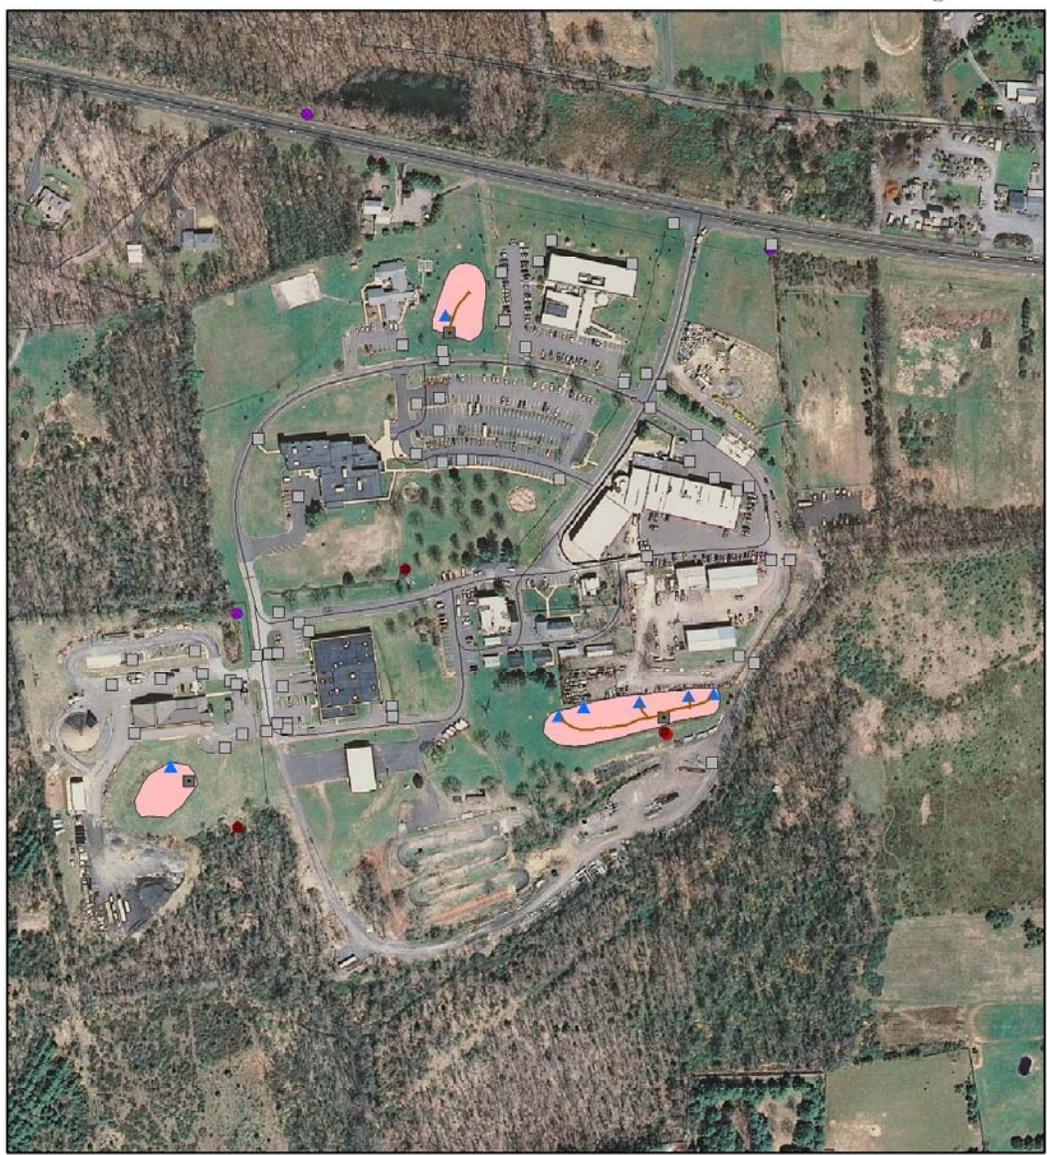
Figure 13: Aerial Photography and Stormwater Infrastructure Mapped at Hunterdon County Complex

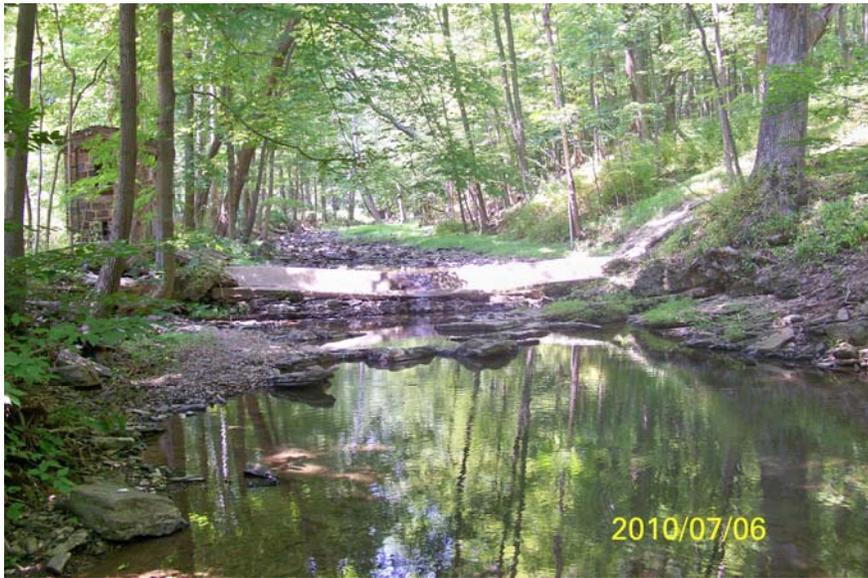
Figure 15: Dam

Dams – These are in stream structures which hold back, impound, or restrict flow. Though not typically considered part of a MS4 they were recorded when noted. This may not be a complete list. A total of 8 were mapped in the study area.

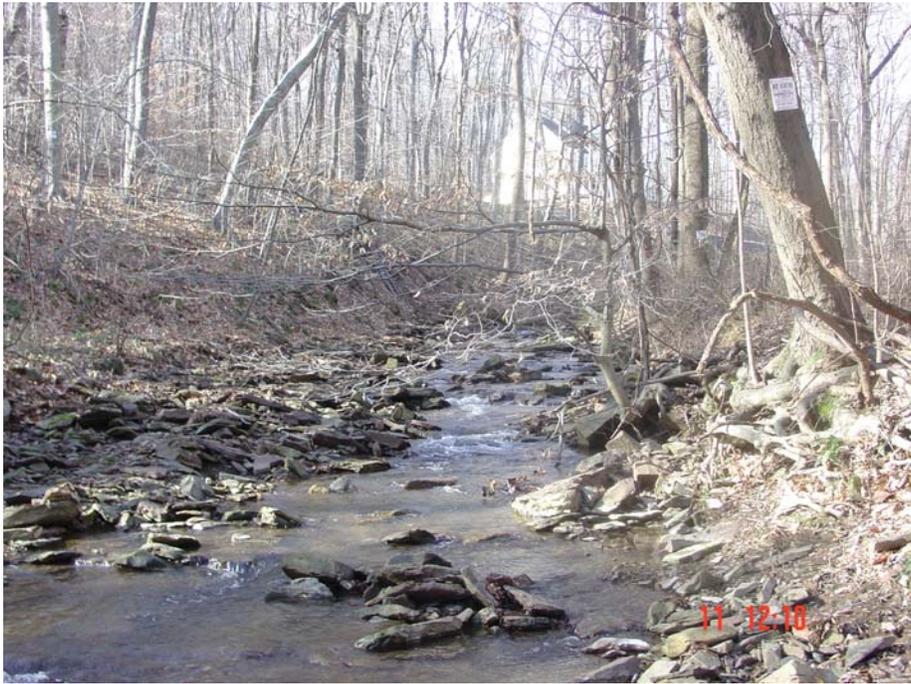
Figure 16: Stream Photo

Stream Photo's While locating stormwater infrastructure the stream corridors were walked. During that process 238 photographs of the stream were taken. Though outside the immediate scope of the project these may prove helpful in the future and will help to establish a baseline of conditions between 2006 -2009. No individual attributes were recorded with the stream photos.
