# Walnut Brook Riparian Restoration Project

## FINAL REPORT

Raritan Township, Hunterdon County, New Jersey

November 2011

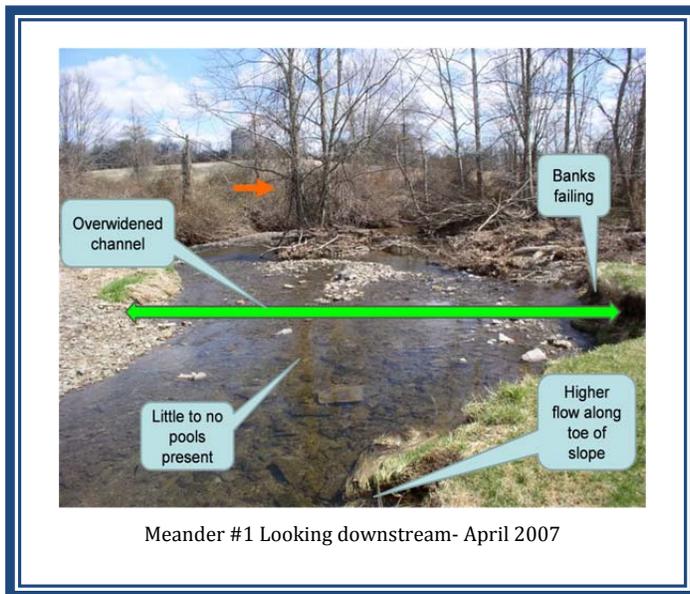
Meander #1 Looking downstream- April 2007

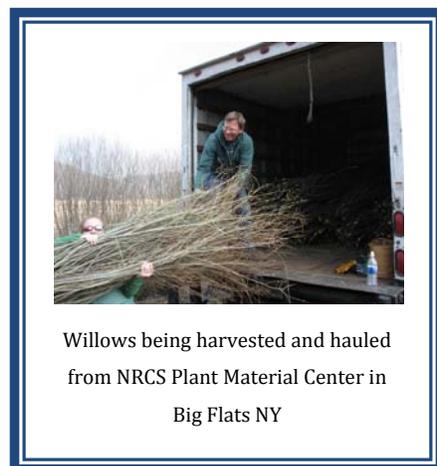
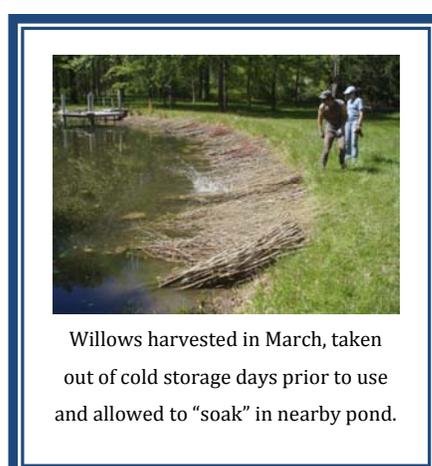
that dormant plant materials needed to be harvested and kept dormant until we could install the bio-engineering practices. Willow cuttings were harvested in March and kept cool (33-35 degrees) and moist in large, walk-in coolers. In mid-June the plants were taken out of the coolers and allowed to soak for 2-4 days in a nearby pond prior to installation.

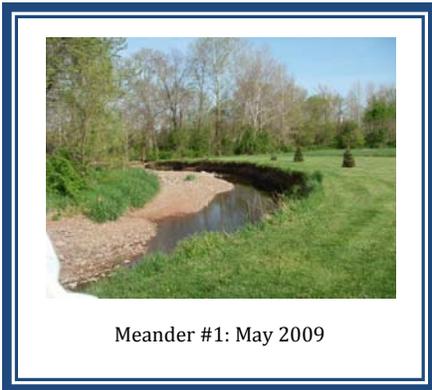
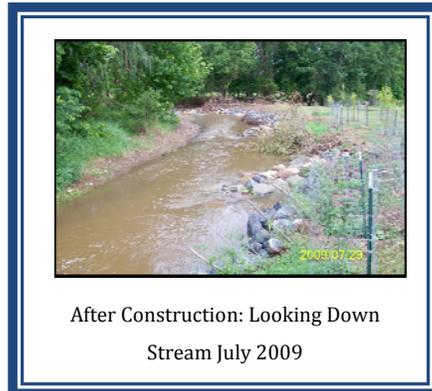
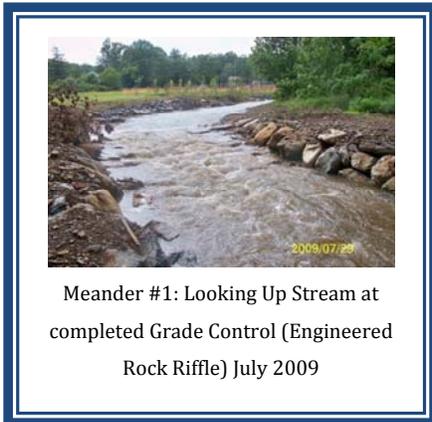
Meander #1's proposed design as constructed in June 2009 included both resistive and re-directive measures to address several problems, including head-cuts and severe

bank erosion. The head-cut movement and channel migration from the time of survey to the time of construction was startling. To address the changes, a large grade control structure in the form of an engineered rock riffle was added during construction. Treatments of Meander #1 included several rock vanes with large keyways and scour pools and longitudinal peaked stone toe protection (LPSTP). The downstream outside bend was stabilized with additional LPSTP and smooshed riprap beneath existing exposed tree roots.

Meander #1: Triangulating Vane construction June 2009

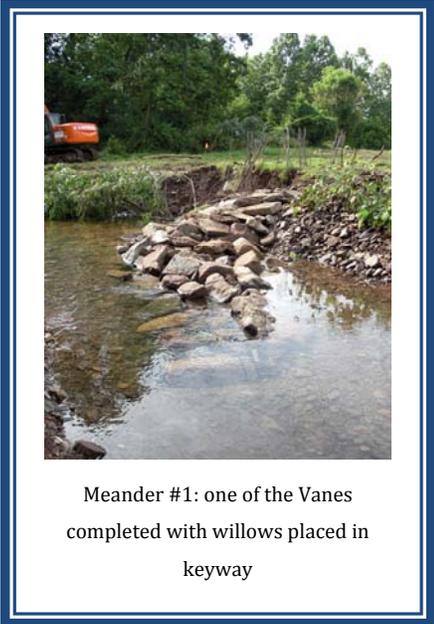
Meander #1: one of the Vanes completed with willows placed in keyway

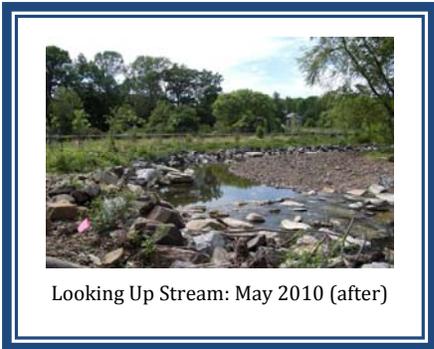
weirs (SSBW) and slit trenches to be planted with willow cuttings. The weirs were placed with LPSTP between them and a grade control structure immediately downstream of the weirs. The downstream limit had a boulder-log revetment locked log structure.

Looking Up Stream: May 2010 (after)

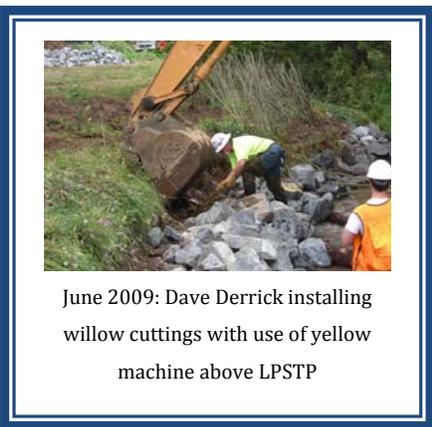
June 2009: Dave Derrick installing willow cuttings with use of yellow machine above LPSTP

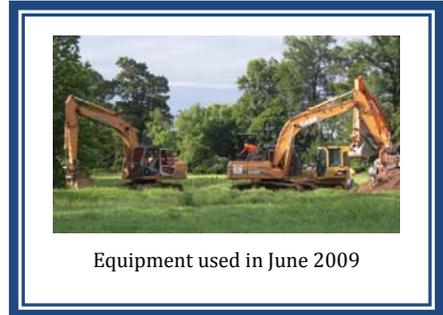
Equipment used to complete the streambank stabilization included: Cat 924 Loader, Case 9020 Excavator, Cat D4 Bulldozer, 621 Loader, Skid Steer, CAT 416 Backhoe, York Rake and probably one of the most important machines was an Excavator with a thumb to properly place the rock for the grade control structures.

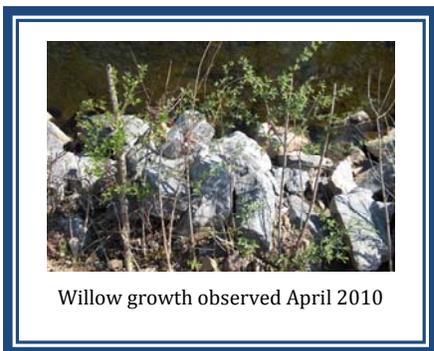
The storm effects on Meander #2 were a different story. A great pool formed between SSBW #2 and #3. The locked logs performed well, as did the grade control structure. It looked great and the team had the alignment correct. To quote one of the design engineers' is was a "thing of beauty".

The willow cuttings installed in June 2009 flourished with the rainy weather the site experienced and achieved good growth. By the time the growing season was over about 85% of the live stakes were sprouting and thriving. The weather pendulum swung the other way in 2010 and negatively affected the willows planted in 2009 and the additional plantings added in 2010.

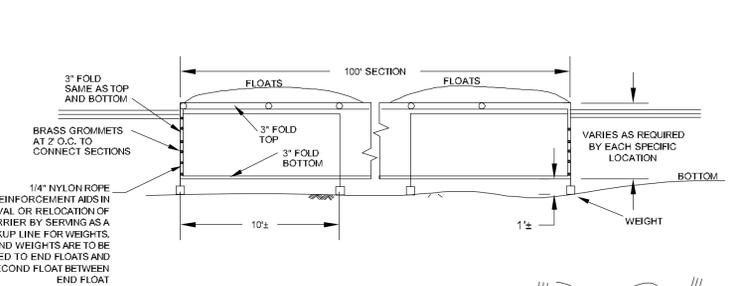
**F TEMPORARY GOOSE CONTROL DETAIL**  
NOT TO SCALE

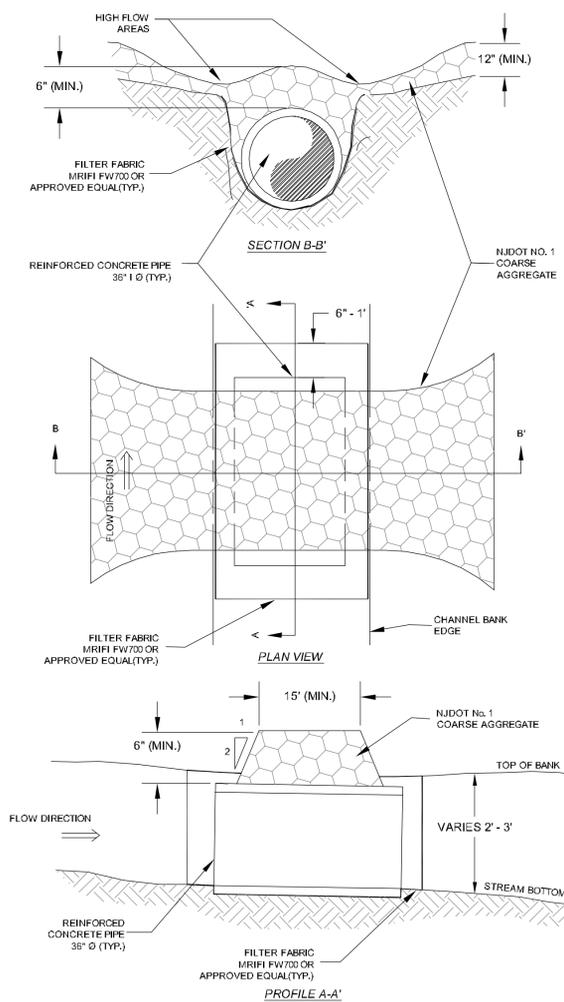
10. THE APPROACH PADS WILL BE REVERSED GRADE FROM THE CROSSING STRUCTURE. IF REVERSE GRADING IS NOT POSSIBLE DIVERSION CHANNELS WILL BE INSTALLED IN THE APPROACH AREA TO PREVENT WATER FROM ENTERING THE STREAM AT THE CROSSING.

**H TEMPORARY CULVERT CROSSING DETAIL**  
NOT TO SCALE

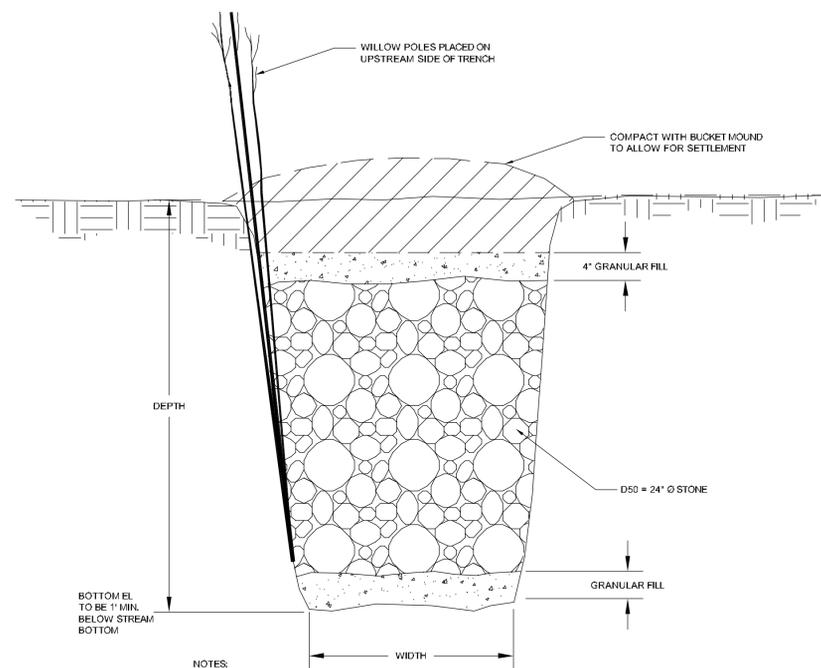
**B** GRADE CONTROL  
 NOT TO SCALE

- NOTES:
- CHOKO VOIDS IN STONE WITH SOIL THEN FILL WITH WATER
  - WIDTH FOR SMALL KEY SHALL BE TWO (2) FEET. WIDTH FOR LARGE KEY SHALL BE BETWEEN FOUR (4) AND FIVE (5) FEET.
  - DEPTH FOR SMALL KEY SHALL BE THREE (3) FEET. DEPTH FOR LARGE KEY SHALL BE BETWEEN FIVE (5) AND SIX (6) FEET.
  - LENGTH INTO BANK FOR SMALL KEY SHALL BE BETWEEN SIX (6) AND EIGHT (8) FEET. LENGTH INTO BANK FOR LARGE KEY SHALL BE BETWEEN TEN (10) TO FIFTEEN (15) FEET.
  - REFER TO PLAN SHEETS 5 AND 6 OF 14 FOR LOCATION OF PROPOSED KEYS.

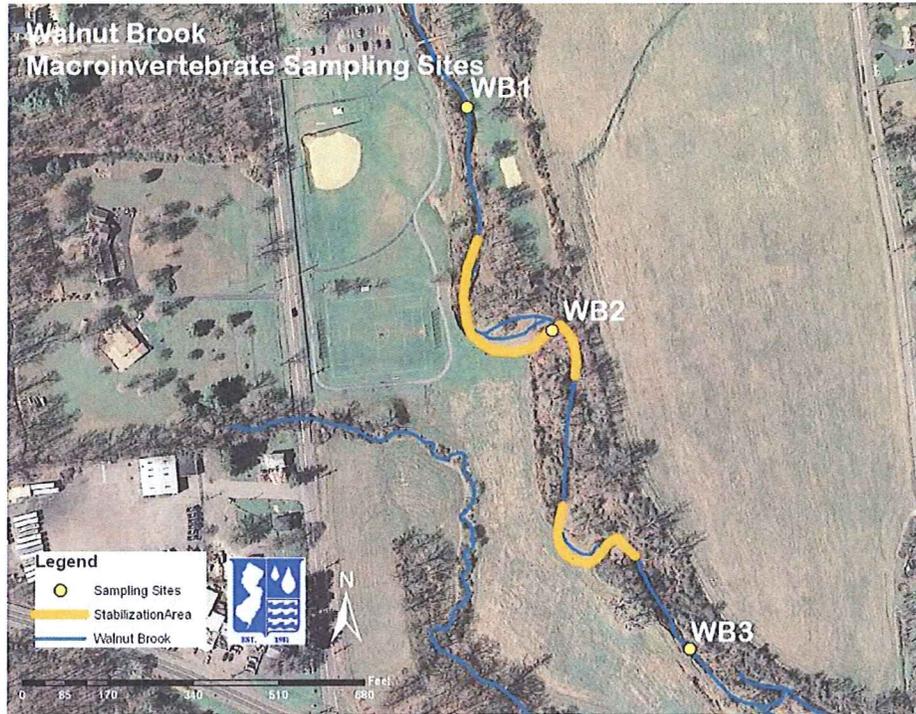
Figure 1

area, one reach was located within the stabilization area, and one reach was located upstream of the sampling area. The figure below identifies the sampling sites as well as the stabilization area.

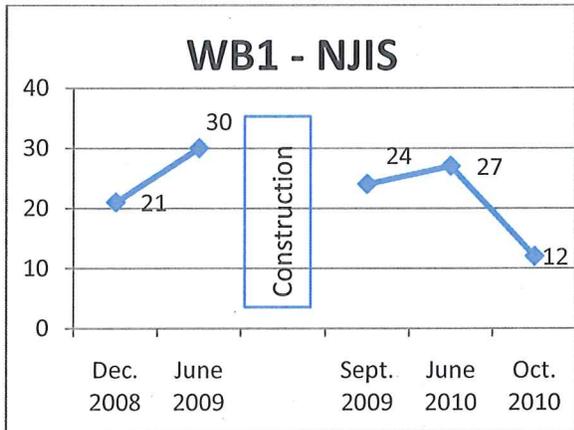
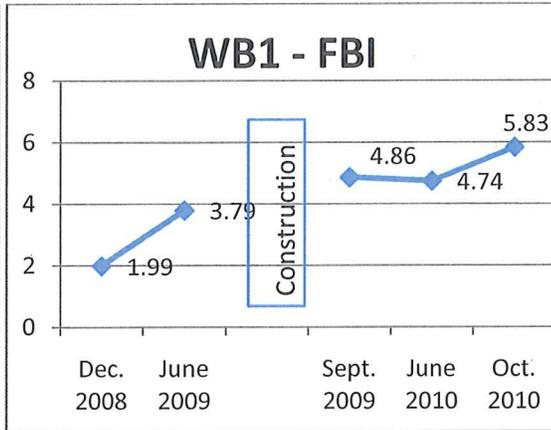
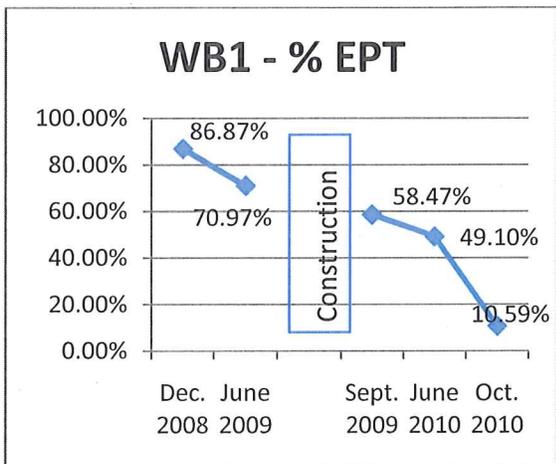
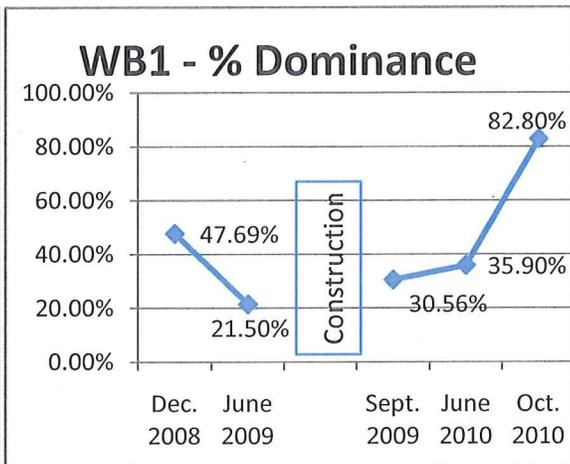
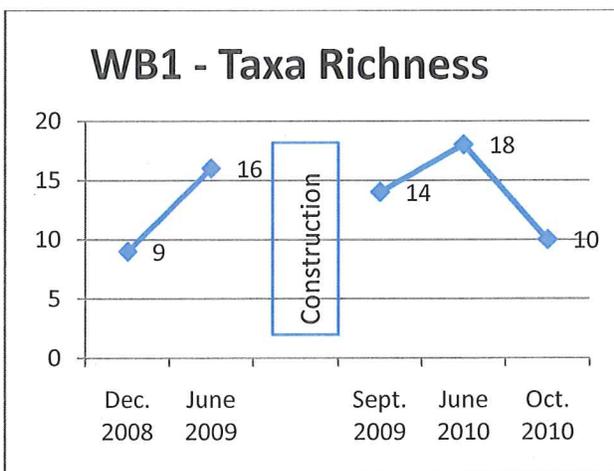
sampling events all received rankings of “non-impaired”. The October 2010 event was ranked “moderately impaired”, but for different reasons than the December 2008 event. The percent dominance and family biotic index (FBI) was much higher during the October 2010 event and the percent EPT was much lower. The graphs below summarize the data observed at WB1.

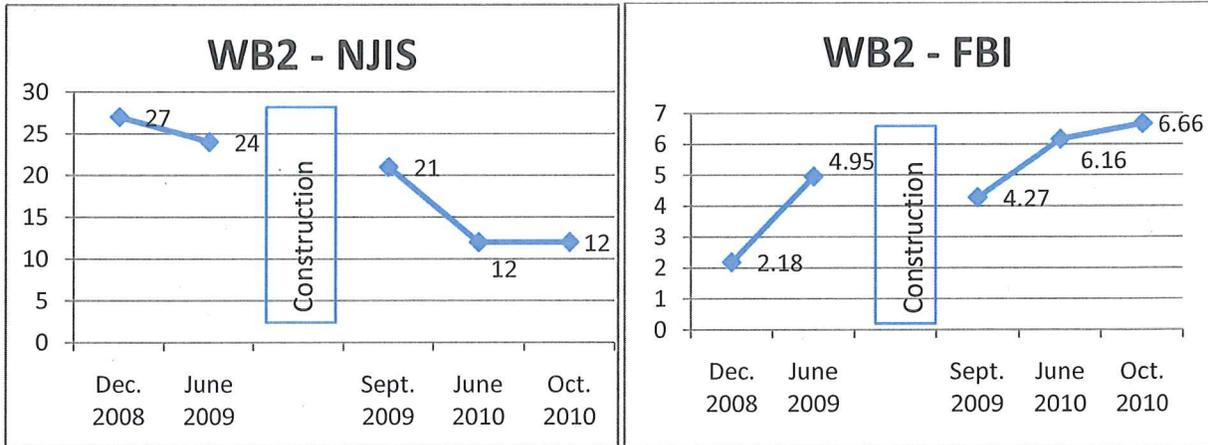
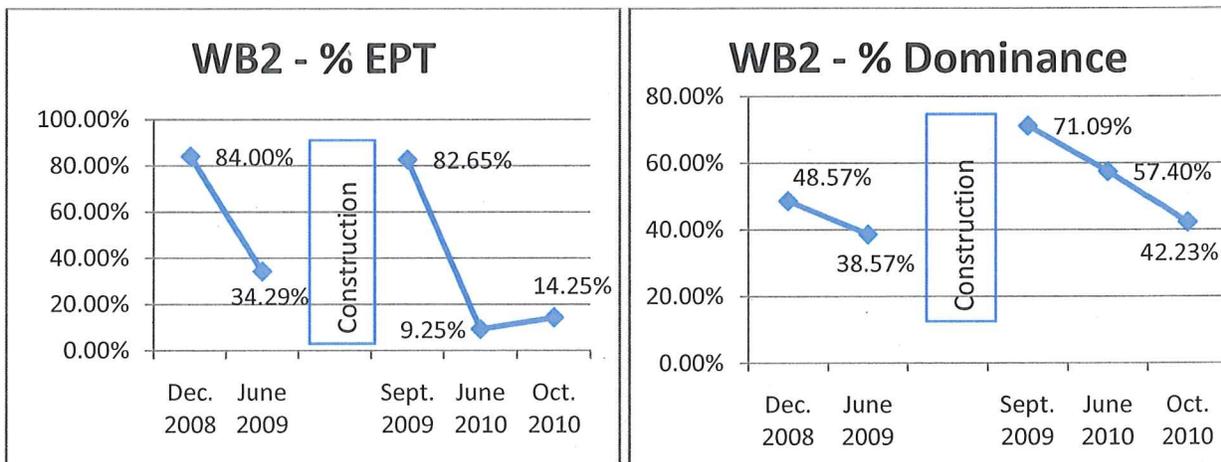
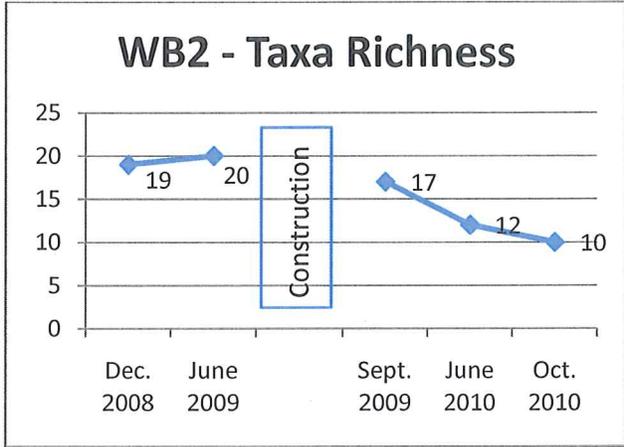
**WB2** The monitoring reach within the stabilization area, WB2, exhibited similar decreases in NJ impairment score, increase in FBI and percent dominance and reduction in percent EPT species present as WB1, however, WB2 did not show as drastic of an increase in percent dominance that was found in the data at WB1. While taxa richness did decrease over the course of the sampling period, the number of families reported did not drop below ten, which still receives the total value for that parameter of the NJ Impairment Score. Due to the changes listed above, the ranking for this sampling reach was changed from “non-impaired” for the first two events in the sampling period to “moderately impaired” for the final three events in the sampling period. The graphs below summarize the data collected at WB2 from December 2008 to October 2010.

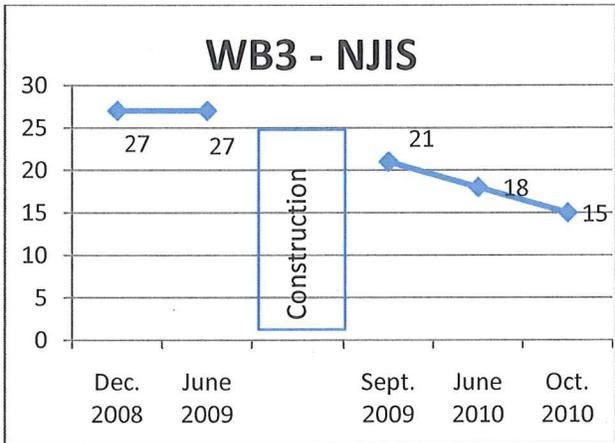
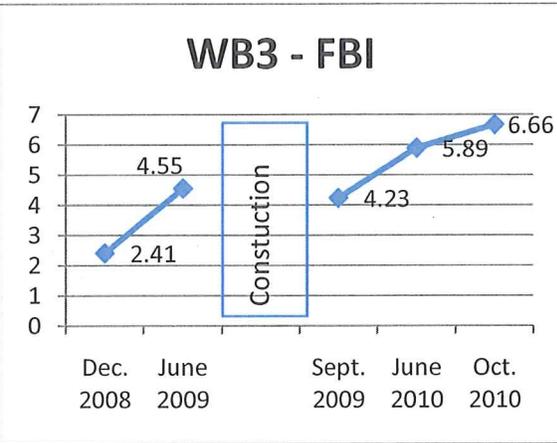
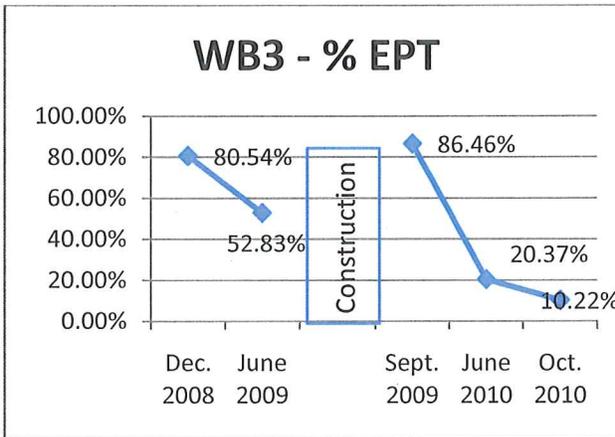
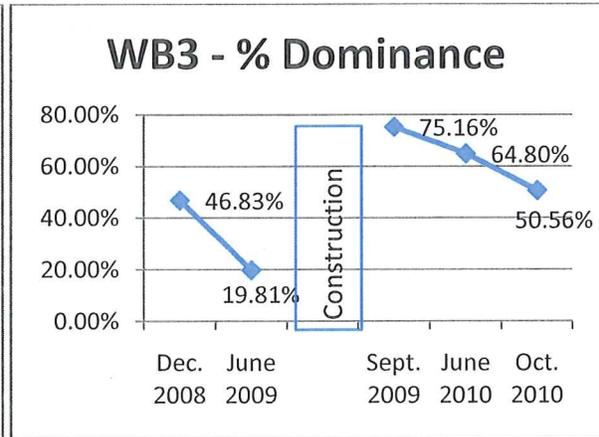
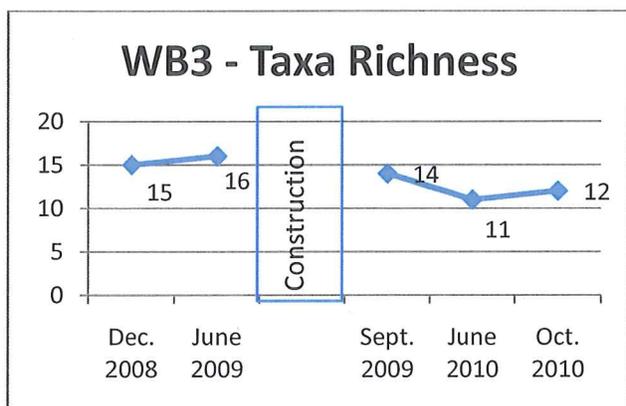
**WB3** Like the two other sites, WB3, the downstream monitoring reach, exhibited decreases in NJ Impairment score and % EPT and an increase in FBI. Taxa richness did not drop below 11 families present. The drop in NJ Impairment score changed the reach ranking from “non-impaired” to “moderately impaired”. The graphs below summarize the data collected at WB3.
