Stream Visual Assessment Protocol

(Modified by the Rutgers Cooperative Extension Water Resources Program, www.water.rutgers.edu)

Stream Name WES HANIC

Reach Location Hampton Corner / Rt 202

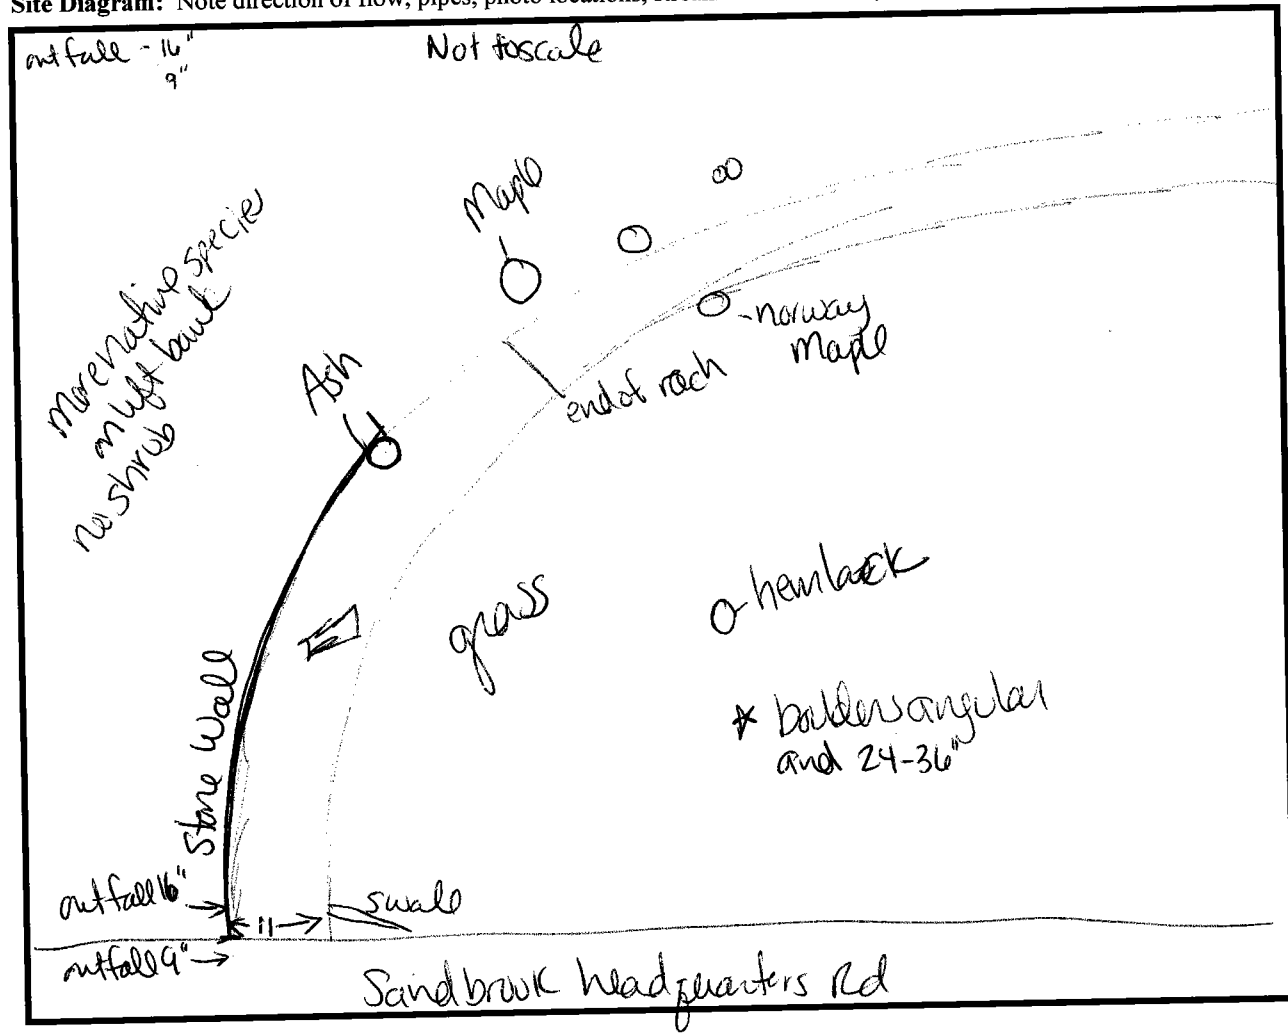
Channel Condition *left side controlled by wall*

Riparian Zone Left: Right: *because of 8' stone wall →*

Bank Stability Left: Right: *left bank is 8' stone wall*

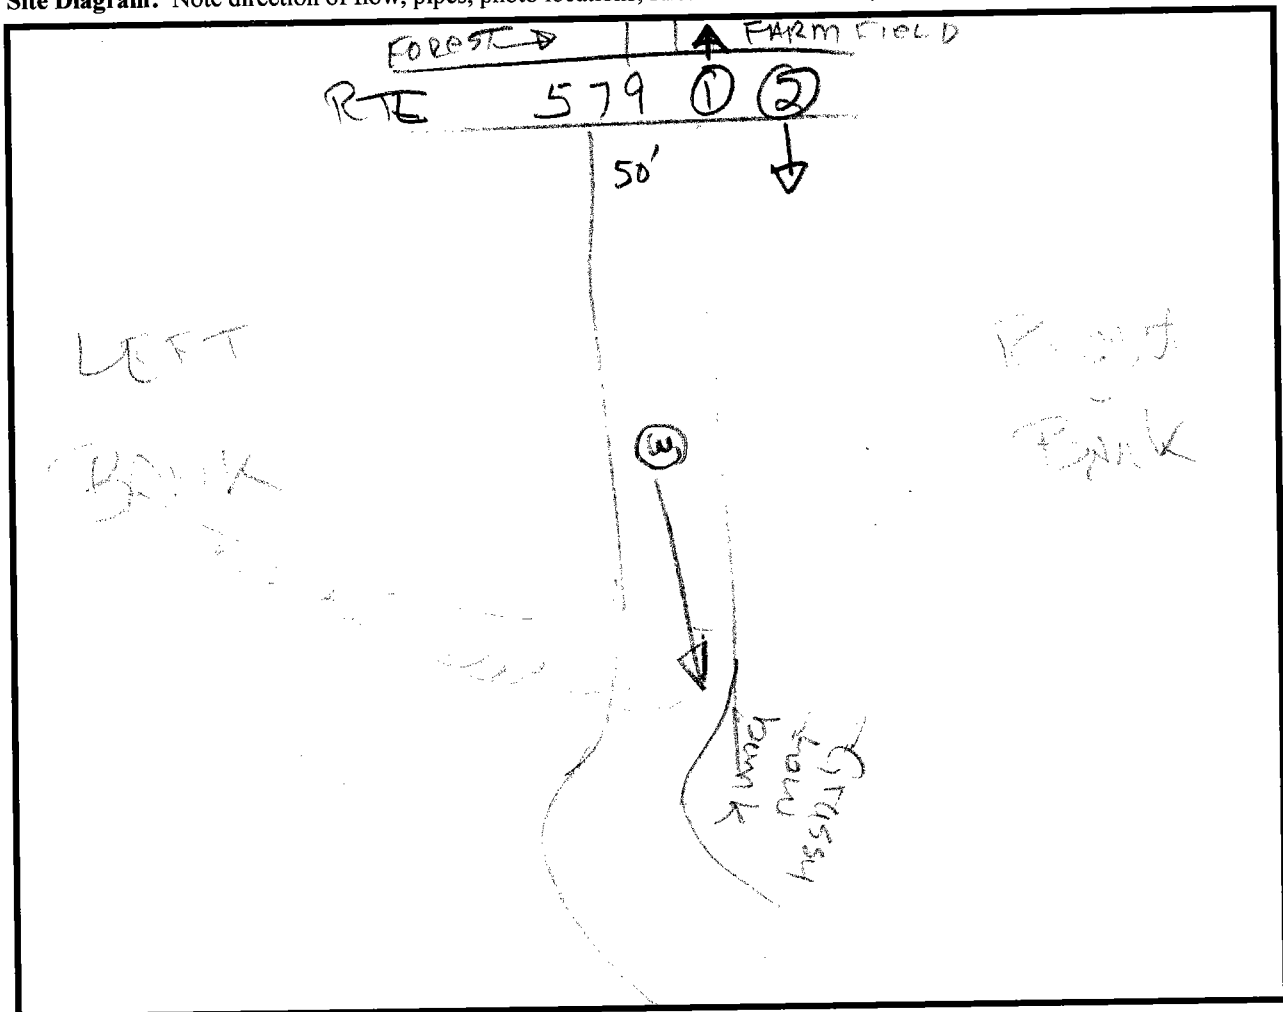
| 1. <u>U/S from bridge</u> | 2. <u>D/S from bridge</u> |

579 BRIDGE scheduled for replacement
current bridge dates for 1838
