### Stream Visual Assessment Protocol

(Modified by the Rutgers Cooperative Extension Water Resources Program, [www.water.rutgers.edu](http://www.water.rutgers.edu))

Stream Name FIRST MESHANIC Grid ID D3

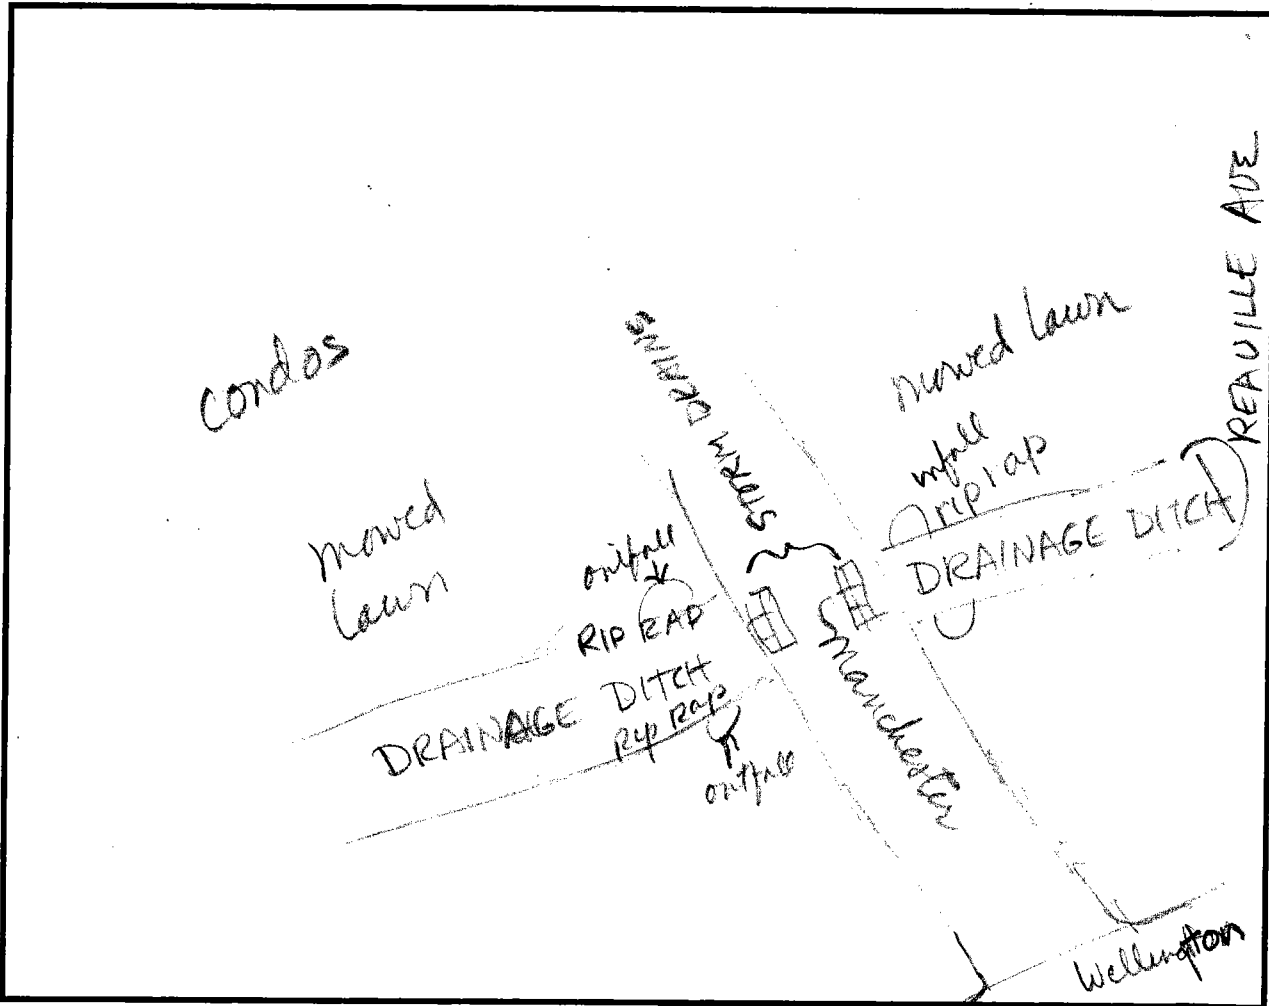
Site Diagram: Note direction of flow, pipes, photo locations, stream characteristics, stormwater infrastructure, & ditches.

Active channel width 3 ft Dominant substrate (circle one): boulder cobble gravel sand silt mud grass

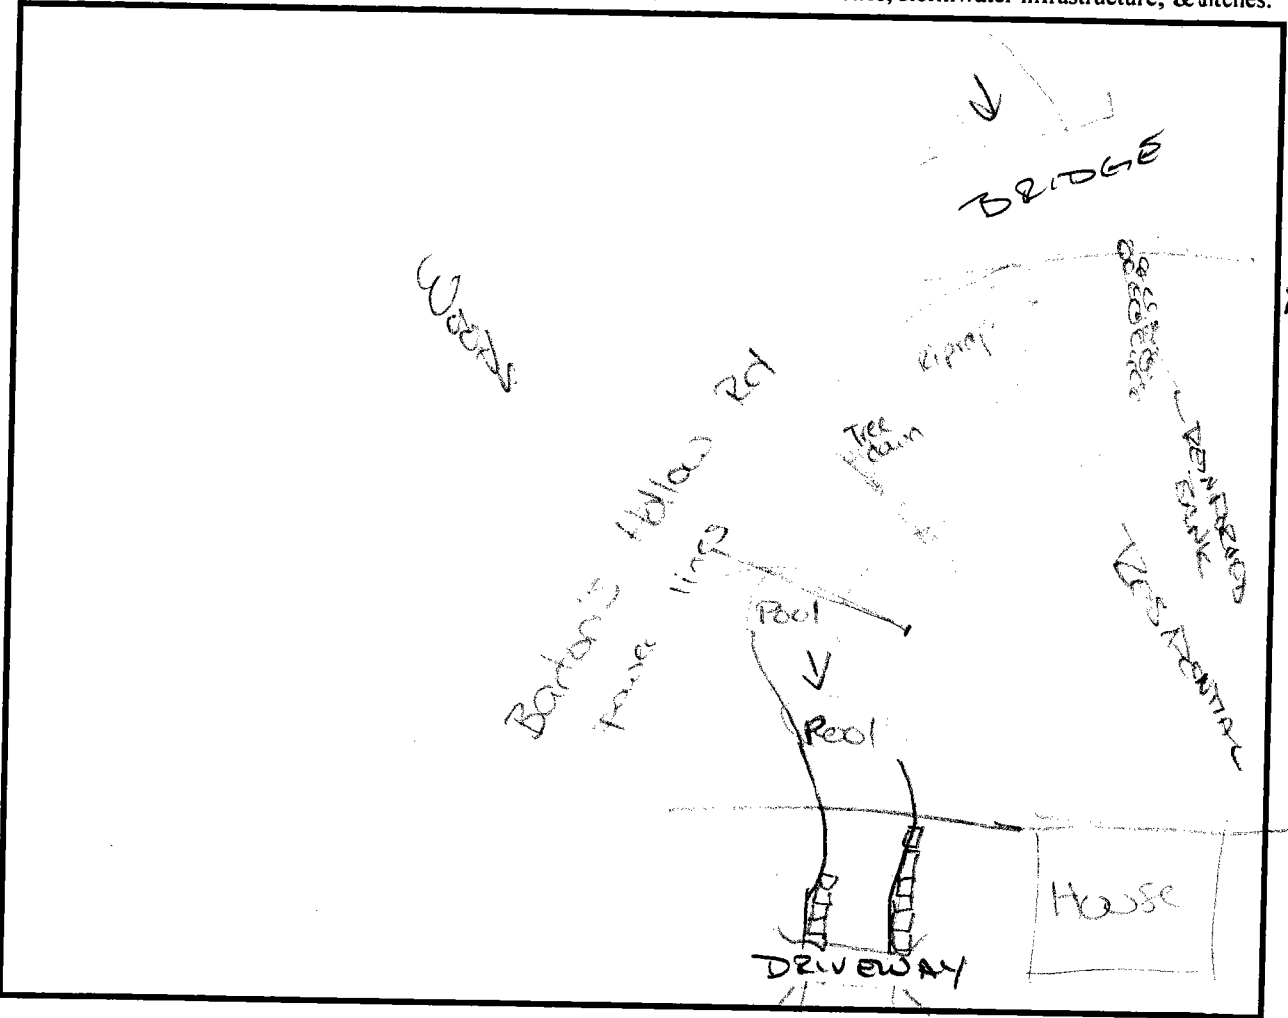
Site Diagram: Note direction of flow, pipes, photo locations, stream characteristics, stormwater infrastructure, & ditches.

Active channel width 14.9 ft Dominant substrate (circle one): boulder cobble gravel sand silt mud

Channel Condition 5

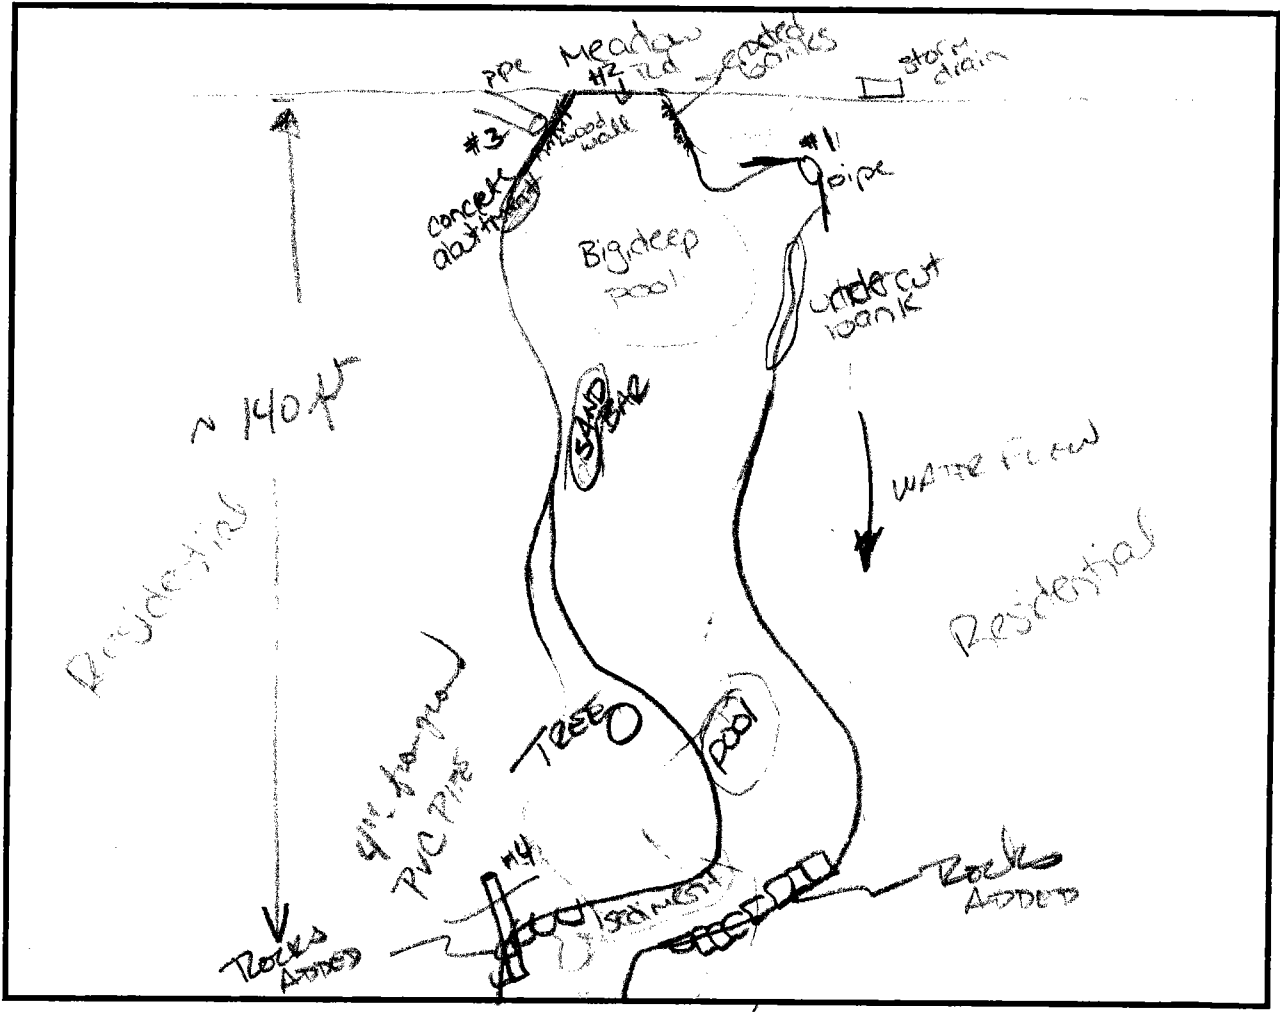
Site Diagram: Note direction of flow, pipes, photo locations, stream characteristics, stormwater infrastructure, & ditches.

Active channel width 12 ft Dominant substrate (circle one): boulder cobble gravel sand silt mud

Channel Condition 3

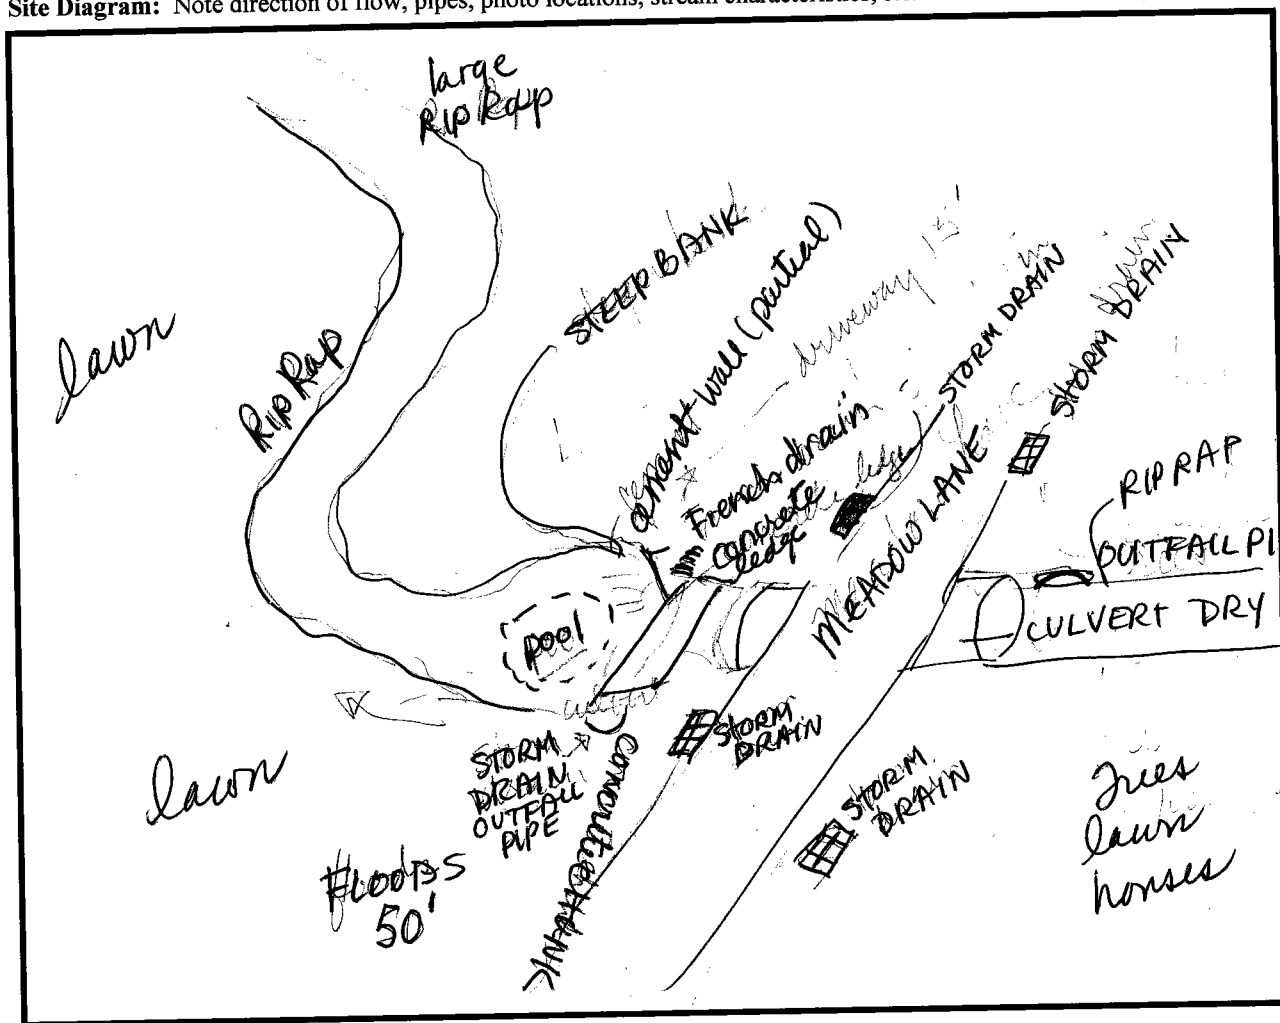
Site Diagram: Note direction of flow, pipes, photo locations, stream characteristics, stormwater infrastructure, & ditches.

Active channel width 9 ft Dominant substrate (circle one): boulder cobble gravel sand silt mud

**Outfall Pipe 1:** (Photo # \_\_\_ and mark on site diagram) GPS Coordinates \_\_\_\_\_ N  
 Diameter: 18" in = BROKEN Left BANK \_\_\_\_\_ W  
 Headwall? YES NO Double culvert? YES NO Streambank at outfall eroded? YES NO  
 Pipe Material: concrete steel PVC Clay Other  
 Location of Pipe: in stream, at top of bank, in bank, out of/ under bridge, other \_\_\_\_\_  
 Channel downstream eroded? YES NO  
 Pipe gathers water from (road, yard, farm, etc.): STORM DRAINS  
 Flow appearance: clear turbid oily foamy colored other \_\_\_\_\_

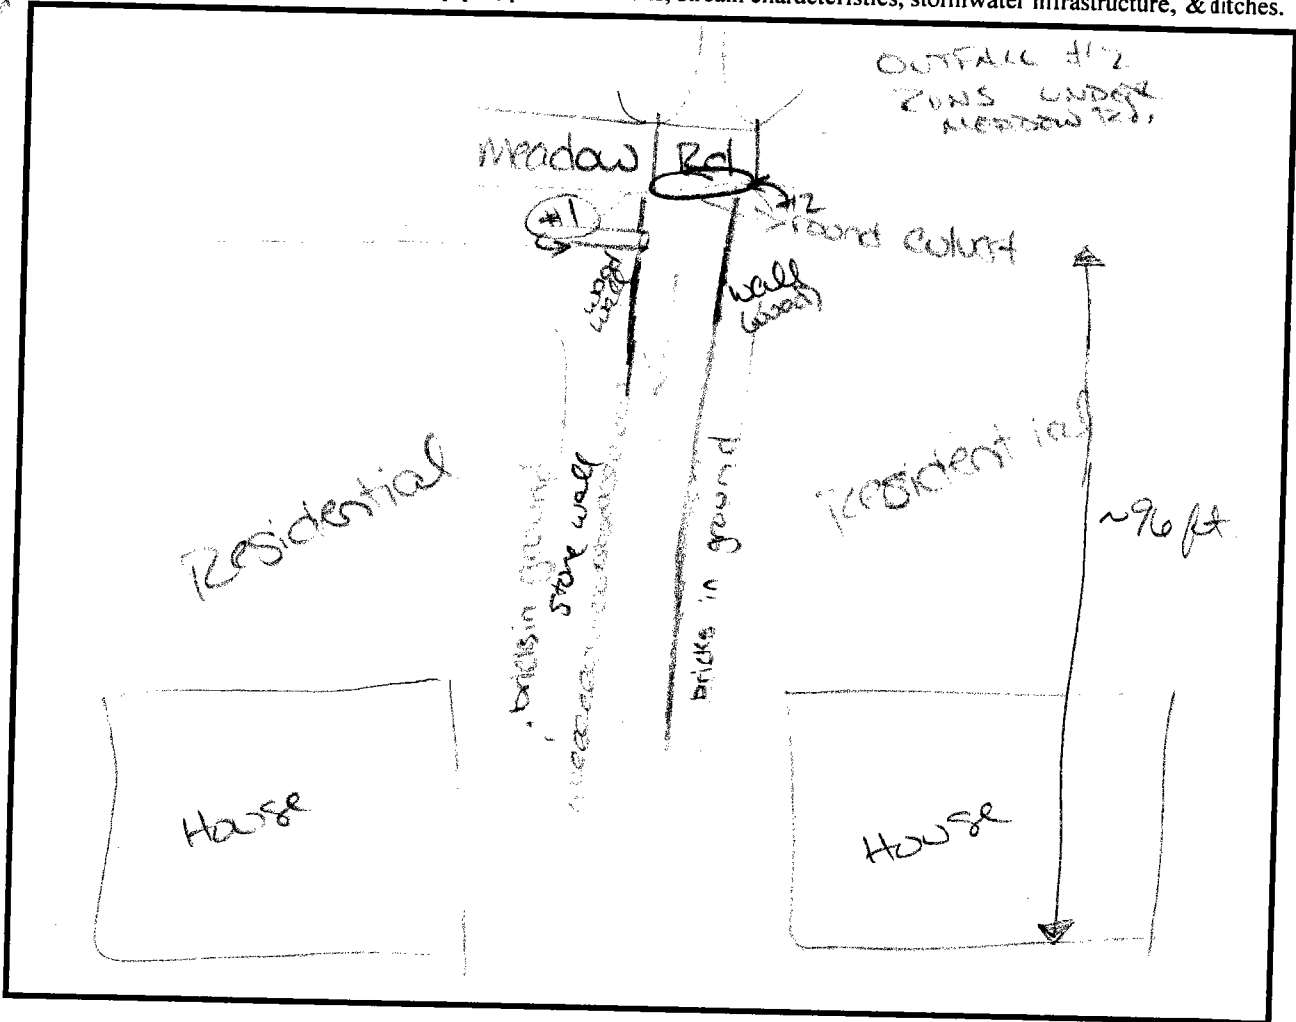
36 Meadow rd  
Flowing
